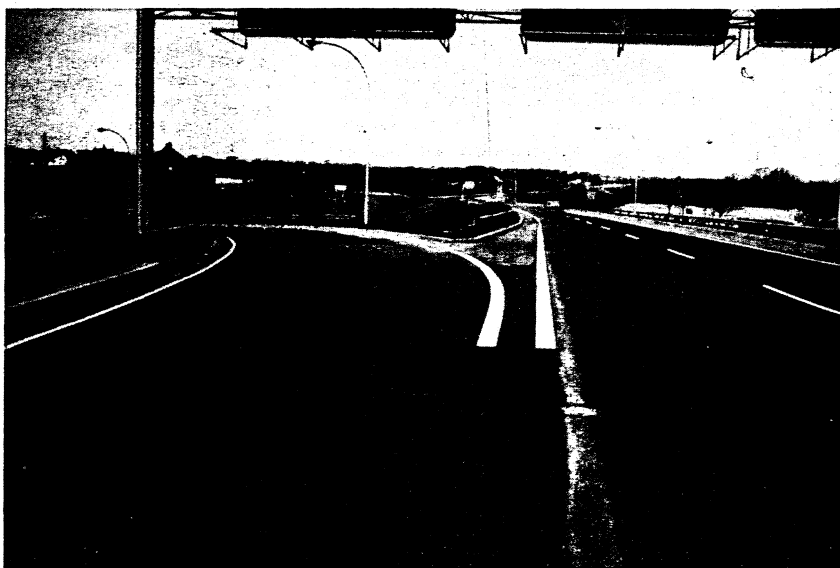
This gore has had its share of skid marks, and again in this location you have guardrails starting here and guardrails starting here [indicating], which are hazards of themselves and desirably should be down to ground level and anchored.

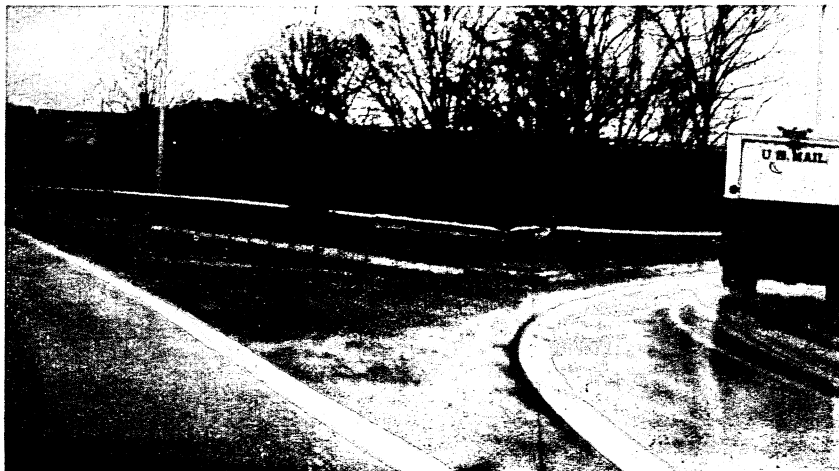
This is a section of gore. This is just off the project, but again a place where a guardrail has been applied similar to the last picture, and it has been struck as you can see.

That is not too good delineation there, nor too good protection of the area.
