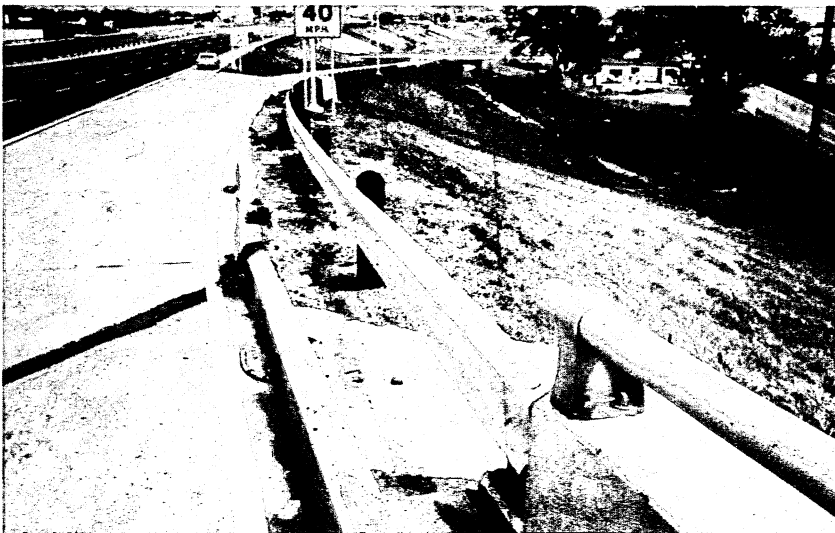
rail at this point. However, back here, the rail fades back behind the curb and the rail would not perform as well back in this area as it does up here [indicating].

Of course, here, we previously discussed the weak points of this anchorage.

Here is the curb so far in front of the rail that it would be a serious handicap to any effective service out of that rail.

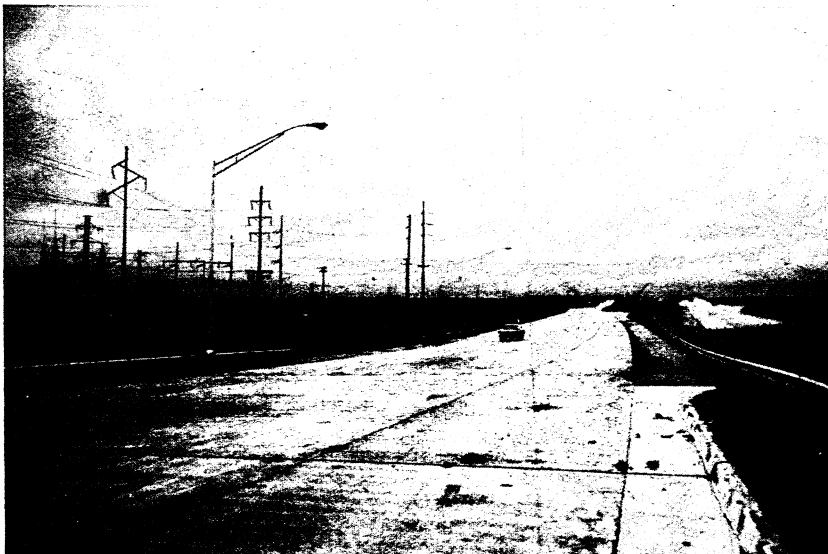
Now we are on the new work in Oklahoma. You will find the median barrier coming up here in the same fashion that you found on the job that has just been opened a few months ago. This work is not
