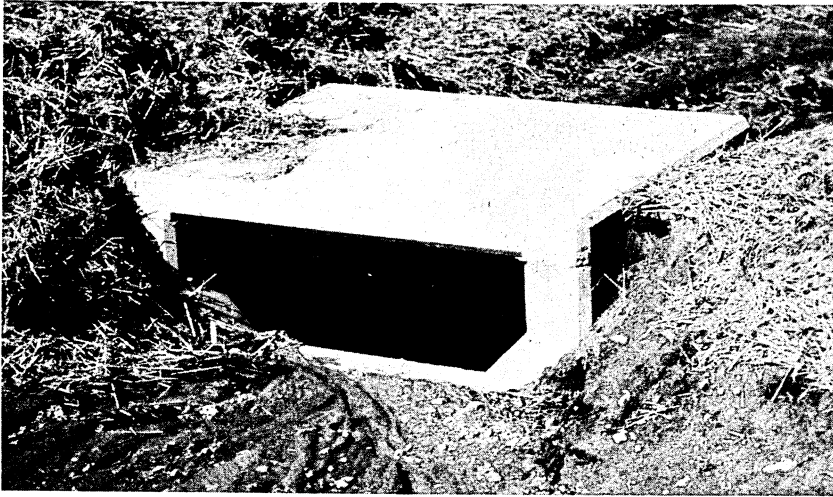
Here we are in Missouri, with a drop inlet in the median, again raised above the surrounding terrain, level of the terrain. This would constitute quite a hazard if hit.

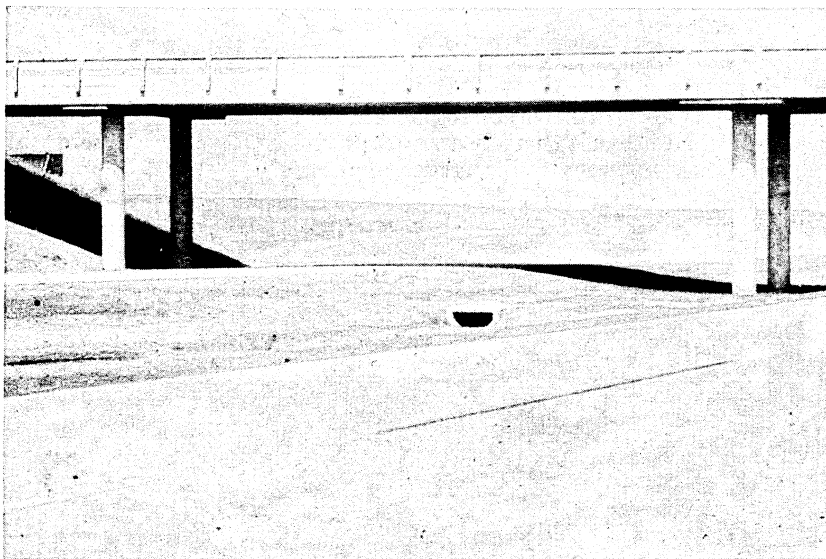
Here, also in Missouri, is drainage carrying through a grade separation structure, a very common type of drain inlet. There is a vertical surface there perhaps 8 inches high to hit.
