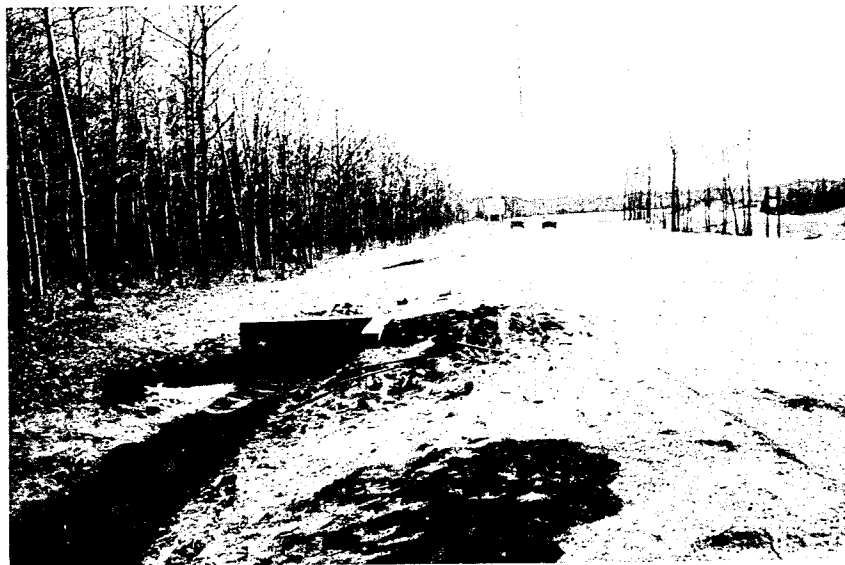
When we come out toward the rural section of this Rhode Island portion, we find this shaped wall, wing wall to handle the culvert which crosses the roadway at this point, which in fact does present a considerable hazard unless the grating is very carefully handled around that point. It looks to me like it is going to end up too high even so, particularly out in this area here. [Indicating.]
