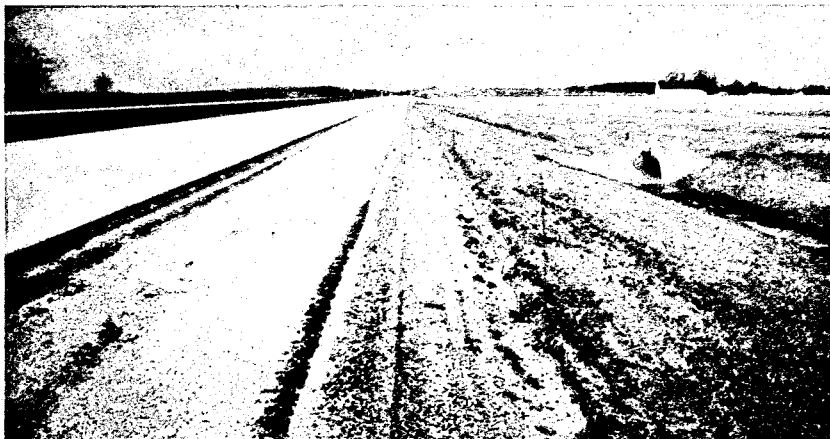
Also in Indiana we found pipes used under the roadway to drain the adjoining land and to handle natural water courses in the area. These are rather large pipes, and as you will see here, they are left open without any guard as far as approaching traffic is concerned.
