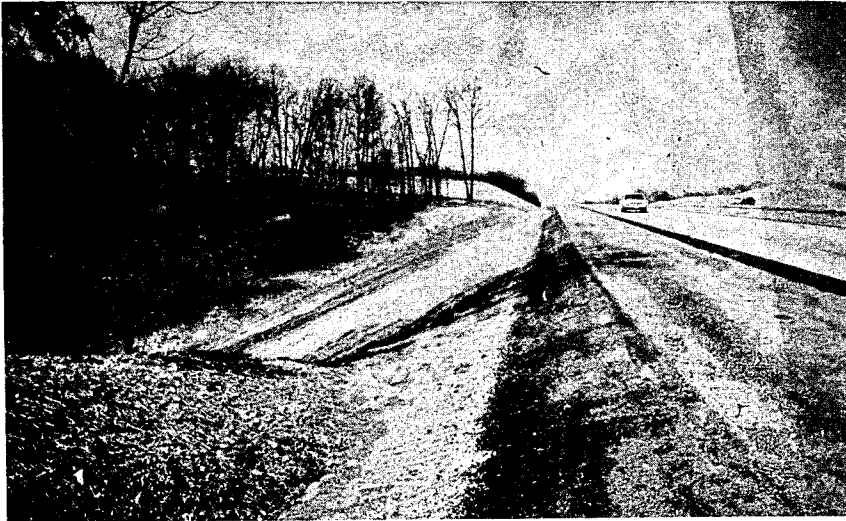
This picture is one on the Missouri project showing the shoulder, first paved 2 feet wide with an asphalt mat, then 8 more feet of treated material, and some slight oiling of the rounded surface. These slopes, as you see, are rather substantial as you move on down here. [Indicating.]

This is the type shoulder that they have. Not any too stable. We understand some additional work is to be done on this shoulder, and certainly is needed, because it is soft now, easily pressed in just walking on the shoulder.

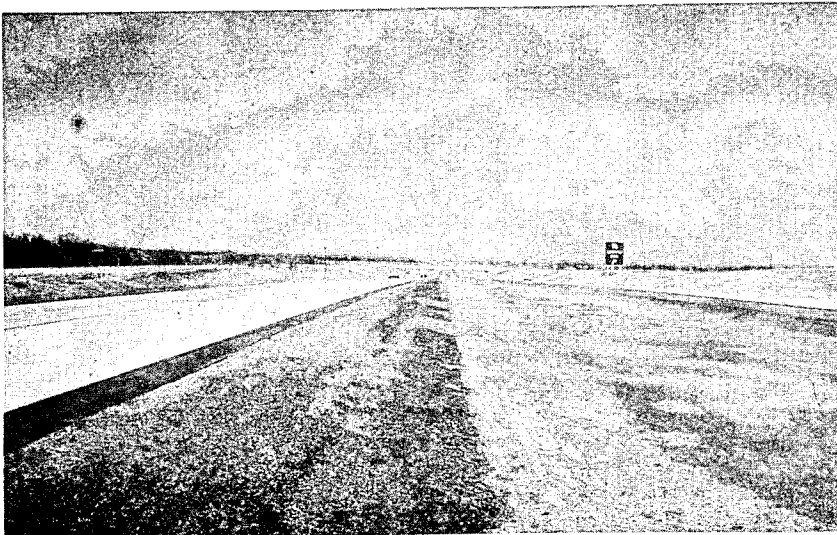
Another view of this same shoulder on the median side, showing perhaps a little bit more transverse slope than is desirable. A shoulder should have a relatively light slope from the edge of the pavement over to this point. [Indicating.]
