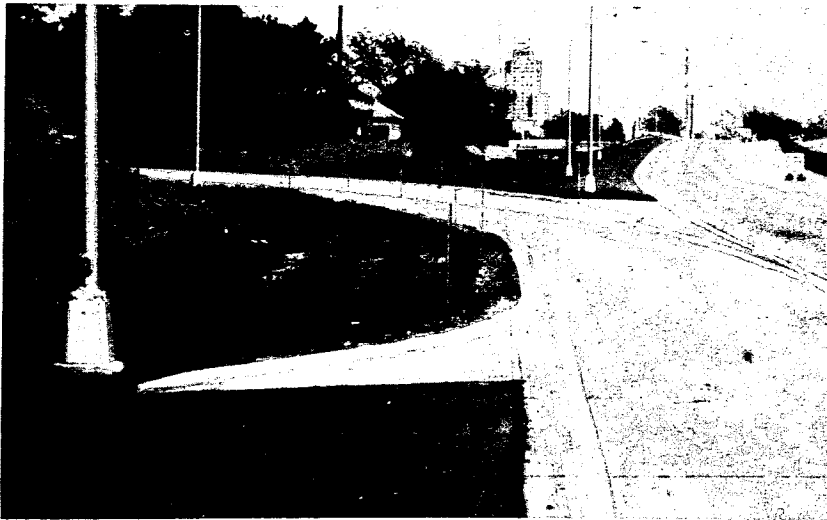
Here is the Oklahoma City project, which has the feature that we saw in Indiana, no shoulders on the ramp at all, both sides curbed. Of course, this is an urban section, perhaps a little more reason for that condition being found here. But we do have the shoulder through this area [indicating] which is cut off at this point, grass, and, in fact, the light pole is installed at that place.

And here you pick up the shoulder again as you move on through the job.

It is a matter of discontinuity of the shoulder. I think it is certainly undesirable. Motorists should always have a moving travel lane with a shoulder alongside, wherever possible.

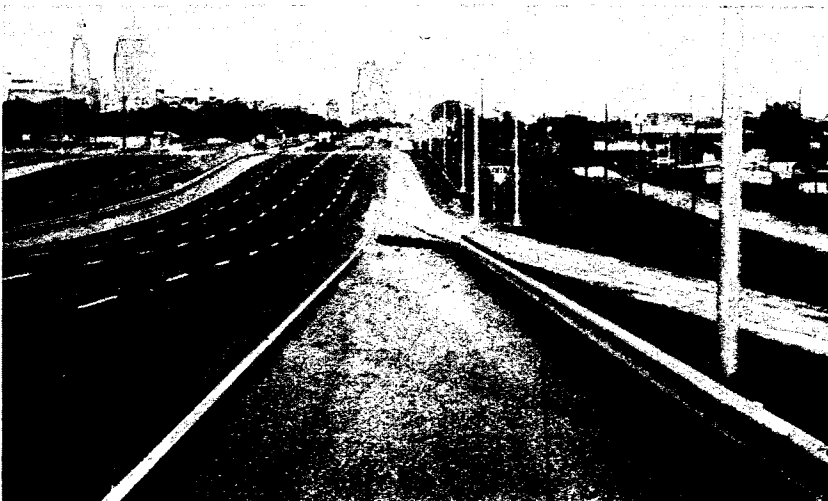
This is another example of how the shoulder gets cut off, and that, of course, shields the entrance movement, but at the same time it does make for an obstruction in the shoulder.
