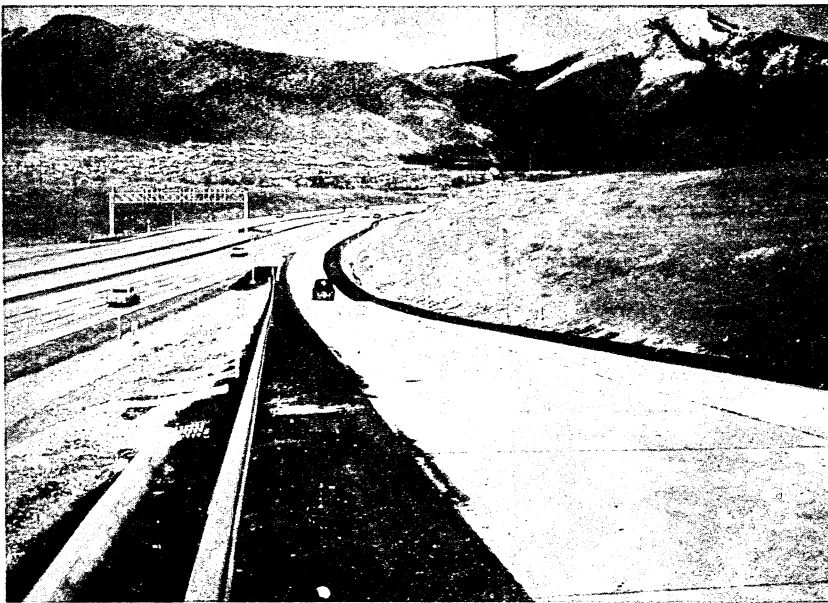
Here is a condition, also on that same Utah project, where shoulders on the ramps are carried on down through the ramp. The ramp alignment, as we pointed out in yesterday's discussion, is very good at this point. But the shoulder cutoff, as I showed you a minute ago, is also evident here.

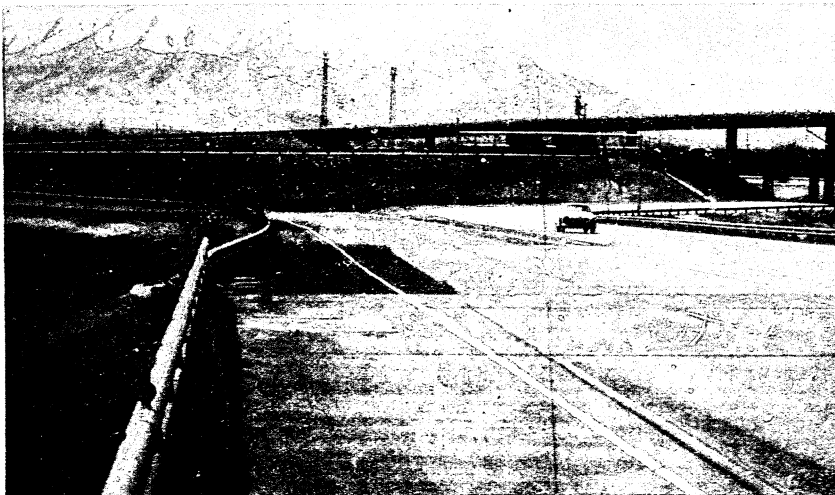
Here, too, is a similar condition which shows how the guardrail gets warped at this point, even though we have a shoulder provided on the bridge. There is no shoulder commensurate in width provided back in this area. [Indicating.]
