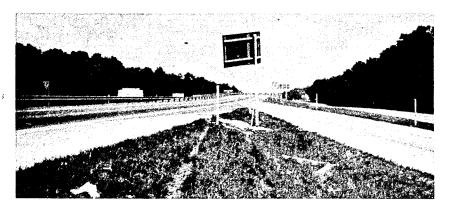
Dr. Keese. This is a typical sign that was hit. In this particular case, the sign worked properly so far as protection of the precious cargo of the vehicle is concerned, but the post broke loose and caused a little more damage to the sign.

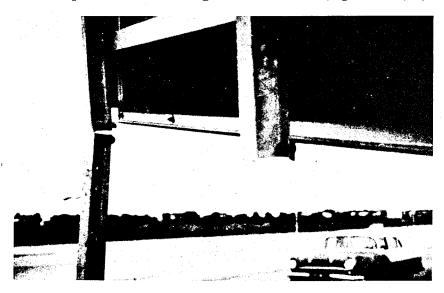
In this particular case here again it broke in half, again no injury.
