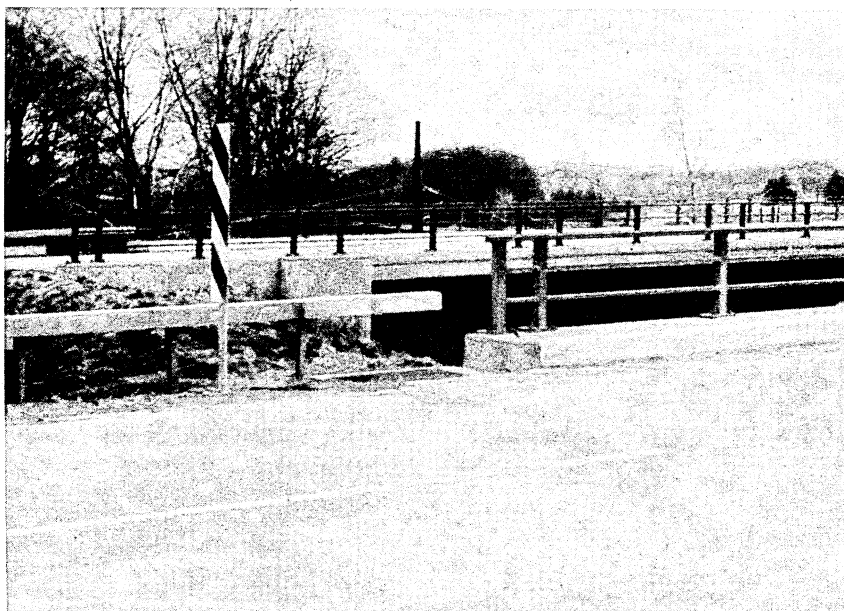
Mr. W. MAY. I believe that again shows the problem of communication and education down to the people who make the installations of these new systems. Is that not true?

Mr. W. MAY. Somebody installed this improperly.

Mr. GRAHAM. May I suggest that not knowing the installation, this is complete, except for the transition section, and is it possible that the transition has just not been erected at the time you took the photo? I am not familiar with the circumstances at all.

Mr. W. MAY. I notice in the photograph here there is a section of guiderail, running at a 90° angle to the shoulder guiderail. Is that designed to prevent people from going down into the space between the twin structures?

Mr. GRAHAM. Yes. We have never tested it at 90°. I am not sure that anything would prevent a vehicle going fast enough from getting down in there. This, I would think, would be a credible job though.

Mr. GRAHAM. No; I did not realize that is what you meant by anchoring the ends. That should be attached to the bridge rail.
