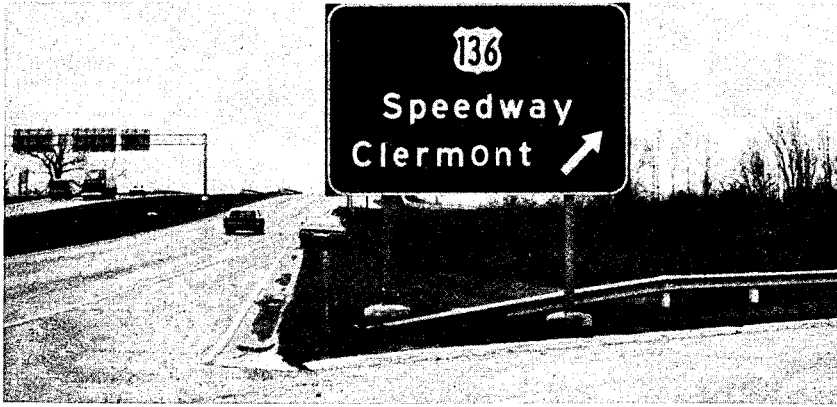
rail. In this situation they have placed the guardrail there at a point between the two legs of the sign, and the sign legs I believe are 8-inch steel beams.

This is the installation that was made initially.

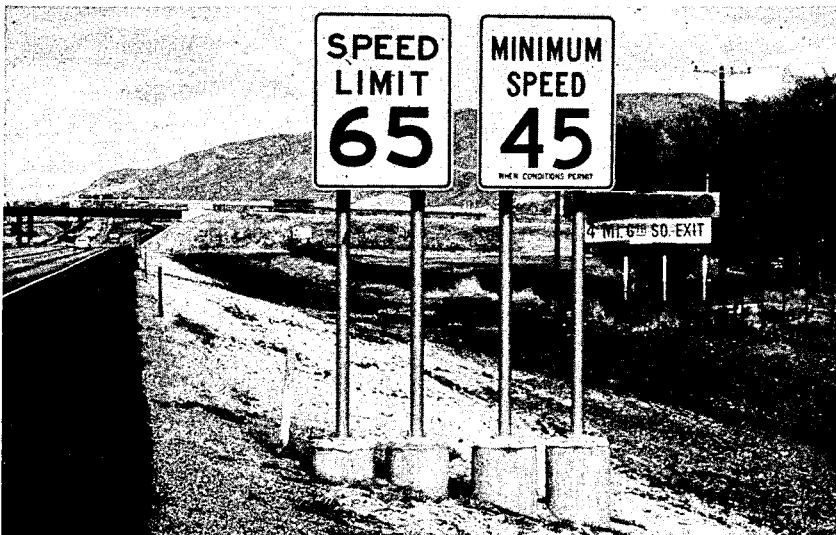
This was the older standard used on a project in Utah with speed limit signs mounted as you see, each with two steel pipes embedded in
