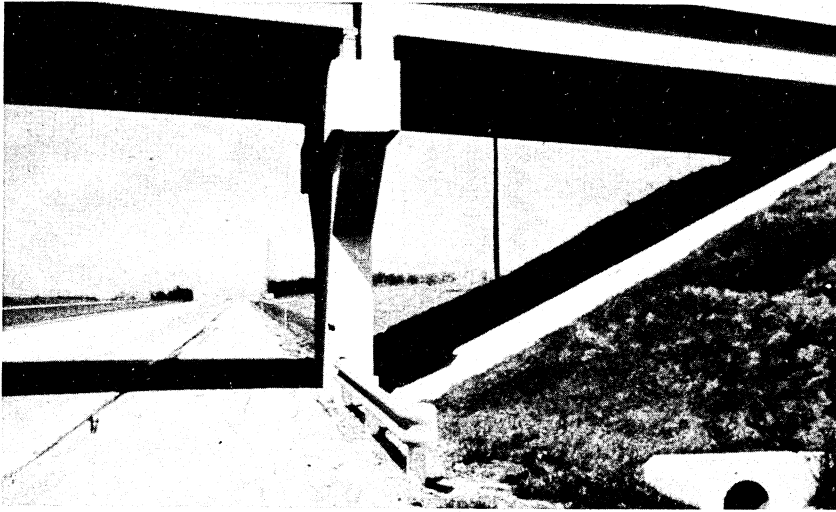
This is another view of the same piece of guardrail which you saw earlier. It is 25 feet in length, aimed directly at the car, aside from the other deficiencies. It is not blocked out, isn't anchored, certainly is not long enough, has 12-foot spacing on the posts, and leads directly into the pier.

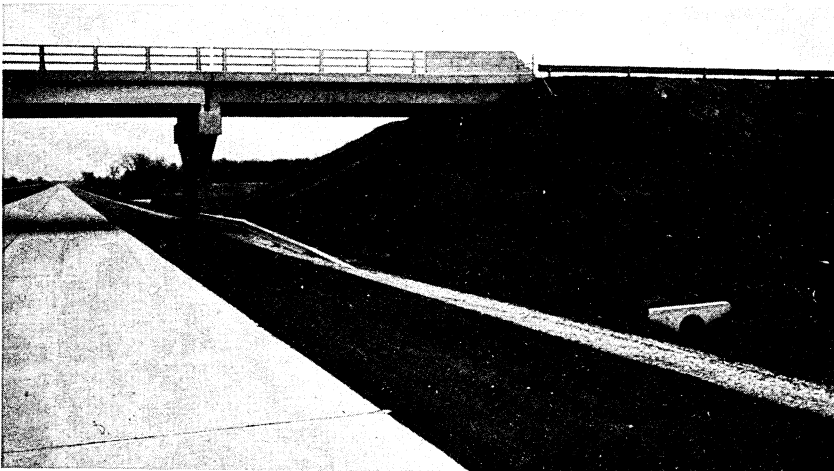
On a newer project we found this situation. The same 25-foot section of guardrail now has an added 25-foot section, which slopes down and is buried into the ground. The other end of the guardrail, however, still ends at and leads into the pier. I question the adequacy of the improved standards here and the expenditure of additional sums of money which doesn't accomplish the purpose.
