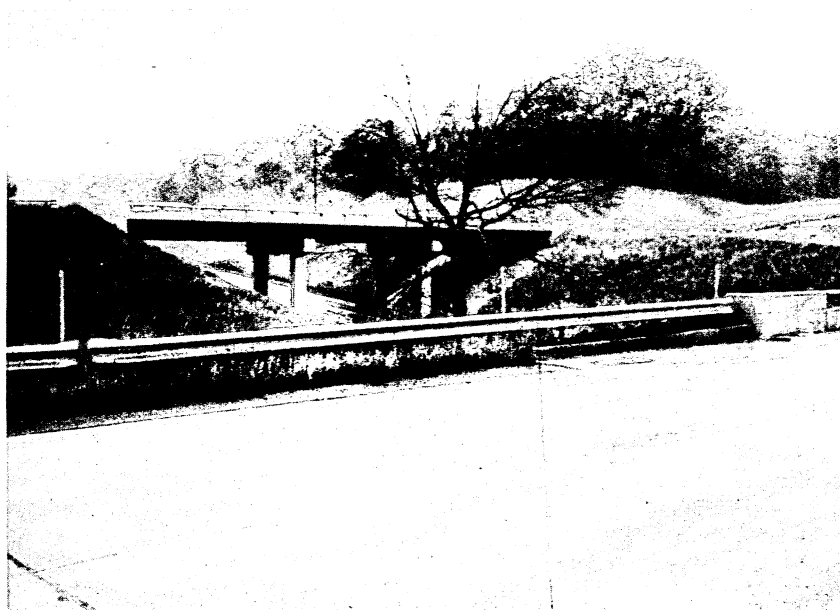
This section, 50-foot section, of guardrail approaches and ends just before the concrete abutment of the bridge. It was installed initially. Thereafter the State highway department concluded this should be a longer approach section for greater protection to the motorist and added a separate 50-foot section without joining them. The car could still impact the end of the new guardrail or if it struck the face of new guardrail, would displace it and cause it to strike the same end of the old one.

I call your attention to that other end of it where it simply goes up to the concrete parapet without any transition to the bridge rail. This is a situation which not only existed on all of the nine projects we visited, but it is commonplace throughout the country. It is perhaps the most typical installation that we saw. No protection in that transition from the guardrail to the bridge parapet.
