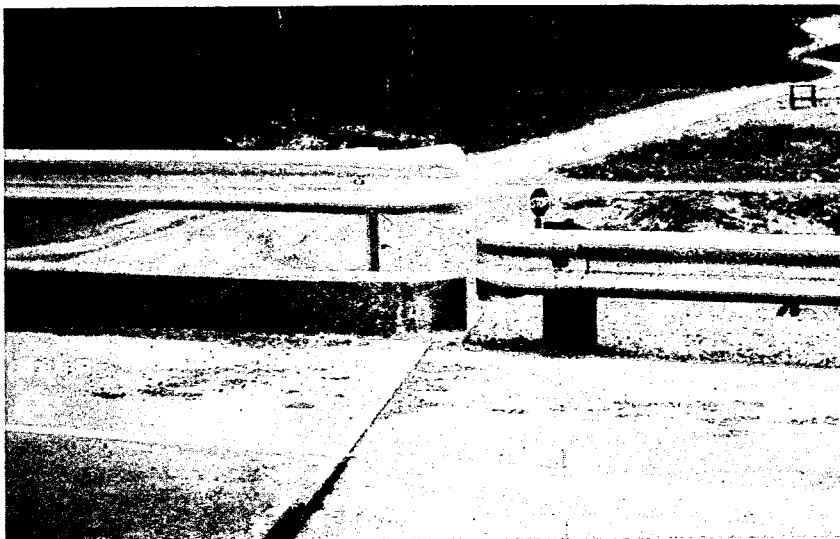
This represents a new design standard. Both bridge and guardrail W-beam, but there was no transition from one piece to the other. Again an attempt to improve the standard. They did carry the shoulder through the bridge and did change the bridge railing.
