HIGHWAY SAFETY, DESIGN, AND OPERATIONS Roadside Hazards

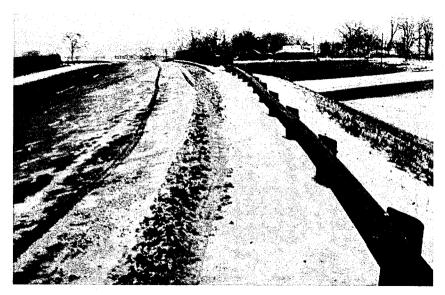
This is an expressway turnoff well marked, heavily signed. There is inadequate guardrailing around the base of the signpost. But 1 day the individual did make this turn, a 17-year-old young man driving his parents in a brand new car, and he swung a little wide. You cannot

really see it, but the road edge is right here [indicating], along here. He swung wide and got into this area

It had snowed during the night. He skidded along the guardrail, which performed like it should; it held, it kept him on track—but the thing is that a few of the legs in here [indicating], near this end, were loose. The car snagged on the guardrail. It then spun around and the left rear door hit the cement monolith, here at the end of the guardrail, crushing the door in, killing the father in the rear seat, and the mother in the rear seat was ejected out the opposite door and down this embankment. She suffered serious injuries.

Had we had these legs implanted more strongly so that it would not rock and snag the car, and possibly the overlap of guardrail over the end here [indicating], this possibly would not have been a fatal acci-

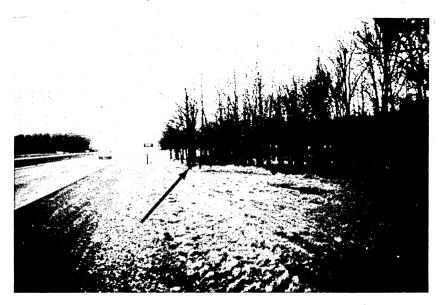
Dr. Huelke. As we proceed farther on the roadway, we see that here the trees are fairly well cleared back. This is going back maybe 50 feet or so, but only a few hundred yards farther down the roadway, we see that the trees are very, very close to the road area. So here we have differences on the clearance of the trees; and these trees are, as I have shown before, quite hazardous.

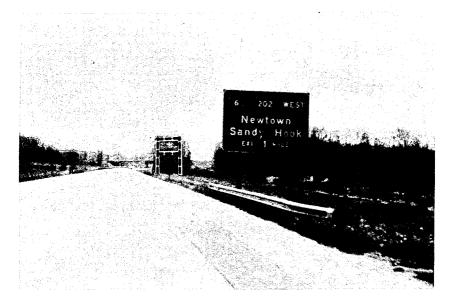
And here also you can see a 1-mile sign. It will not make any difference if you back these up behind that guardrail. You can put it at three-quarters of a mile rather than 1 mile, when that creates an unnecessary hazard.

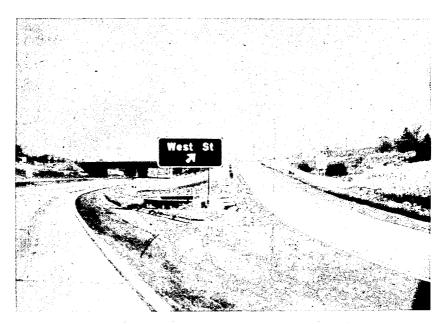
Here is a place where you have a clear gore area and a clear road with a nice shoulder, and they have about 200 or 300 feet of guardrail somebody might run into and which could be removed. I have a line there to mark the guardrail.

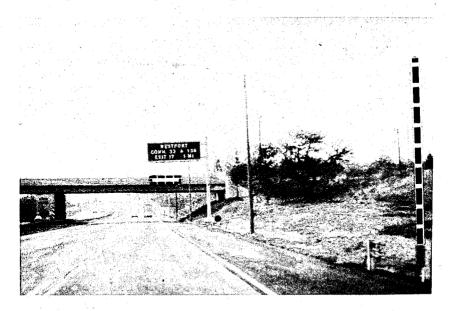
Here you can see where the sign could have been mounted on top of the overpass or back up where the guardrail is, where the marks are.

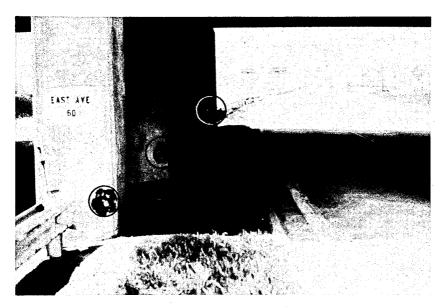
Here you can see the sign could be mounted on top of the overpass and the pole could be put inside the center divider. Every one of these places is an extra snag. Even at the bridge support, the guardrail does not go around it; it stops in the center.

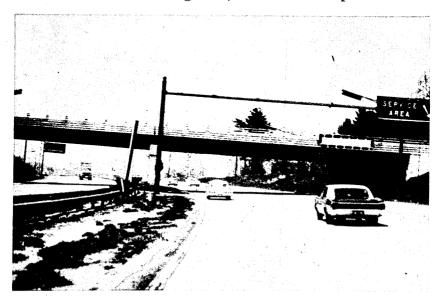
By the way, the center rail was a new rail. It was recently installed and they failed to protect these hazards. The least they could have done was install a few more feet or guardrail and phase it into the center rails.

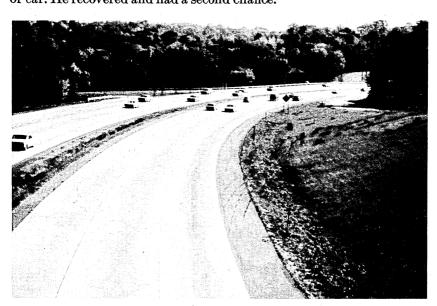
Here you see another car running by, barely missing a tree on the top. Now, in many places we have been planting these trees 2 and 3 feet off the shoulder, you see. He would not have gotten a second chance. I am trying to illustrate what happens to cars and trucks in their way back and forth to work.

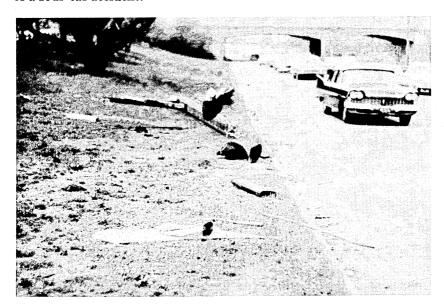
Today on our new planting on Interstate highways, we are planting these trees just about where this one is and we have not learned a lesson.

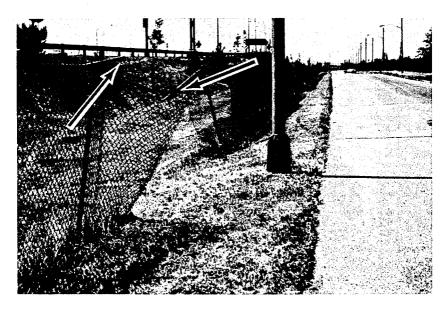
And here you see where it did go into the driver.

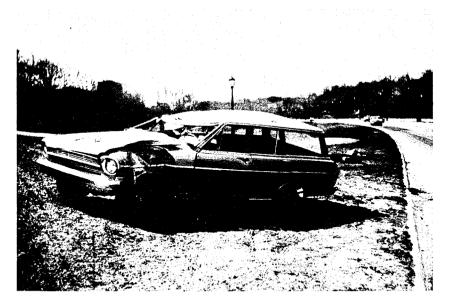
Here is another picture of the car, unnecessarily damaged.

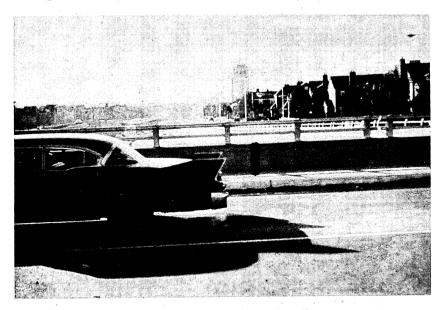
See? It could be a concrete wall, which I would recommend. Here is a steel railing. You might think after all those things I said about aluminum, that I do not like the aluminum company; but that is not true. Here is steel rail, it has a poor design. Notice that the upright is about 5 inches wide, but they slotted it 3 inches, so actually

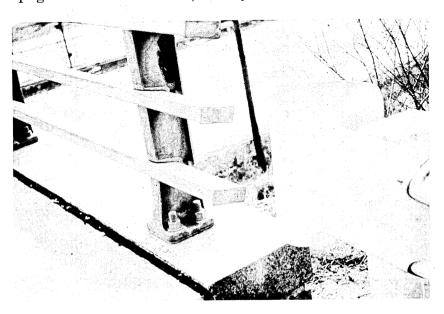
the upright is only 2 inches wide here. When somebody hits that, it will snap off right where the weak part is. In other words, you have 2-inch uprights holding this up. I am sure it cannot hold back cars. And this shot proves it, because as soon as somebody tapped it, it broke off where the 2-inch section is.

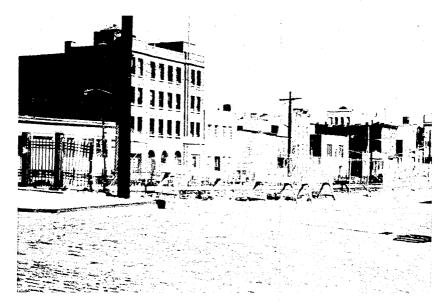
Here you can see where a couple of people got killed. Sometimes they are electrocuted, other times burned to death. Maybe 10 or 15 cars fell on these tracks in this area here. The city and the public service commissioners are arguing who should pay for the guardrail there, the railroad or the city, and they have been squabbling for years now.

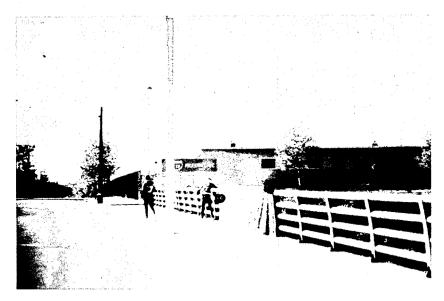
Here you see they do not have to throw it; they just drop it on top of cars, because we failed to put proper fences there.

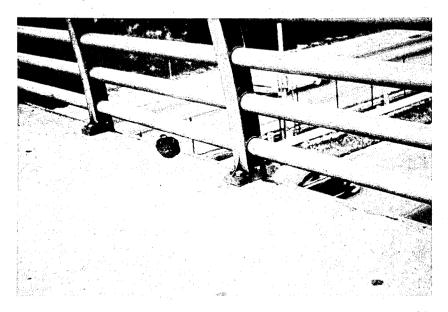
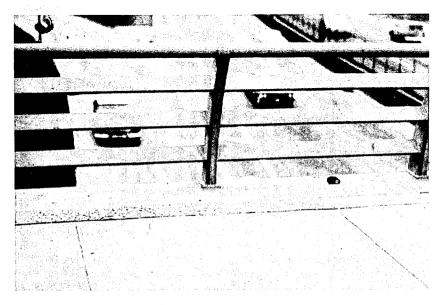
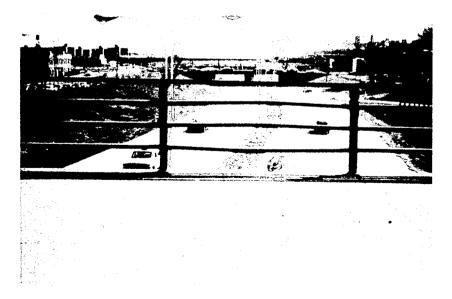
Here are two shots on Interstate highway where we failed to provide fencing or any curbing ledge below the rail. We have to get to these places and fence them before something serious happens.

The three foregoing pictures show that under the right conditions something could fall on the windshield of cars below and even cause a four- or five-car accident.

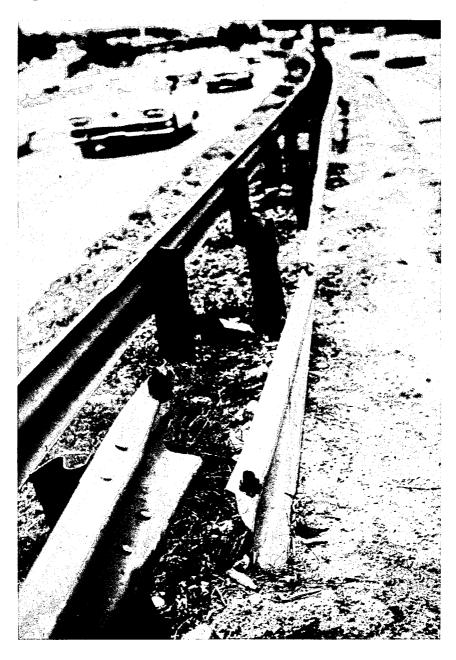
There is practically no damage to the rail, but it snapped right in half.

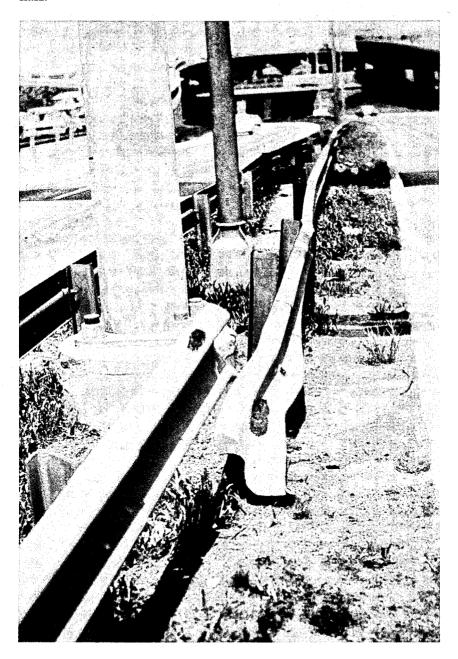
Here is the ideal picture, there is not a dent in that rail. The rail is split, so the material just cannot be any good. Even at this late date—and I brought it to most people's attention—we had the nerve, just in 1966, to go back and use this type of material again on our Grand Central Parkway. All they had to do was look around and see the hundreds of places where the cars have broken through—not only through single rail but through double rail.

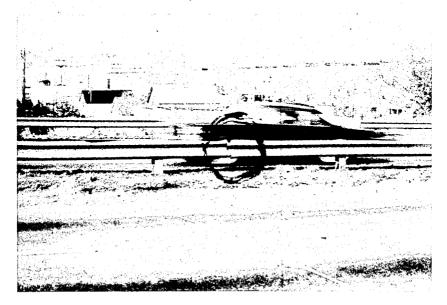
Here is a steel rail, somebody went right into it and I do not see any crack in there. It is just twisted, bent, and it held up and did the job.

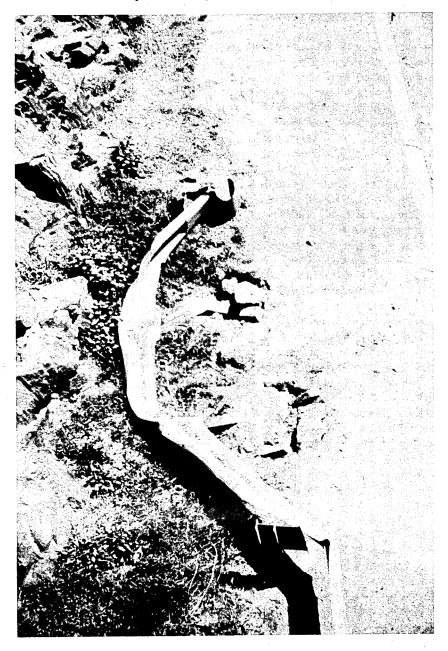
But this is what happens to the aluminum rail; it just cracks and splits.

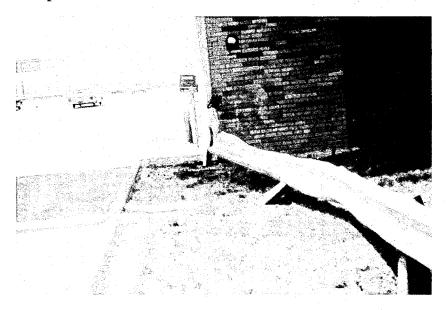
This shows it did not even crack where it was hit; it cracked somewhere else. The guy got in trouble for nothing.

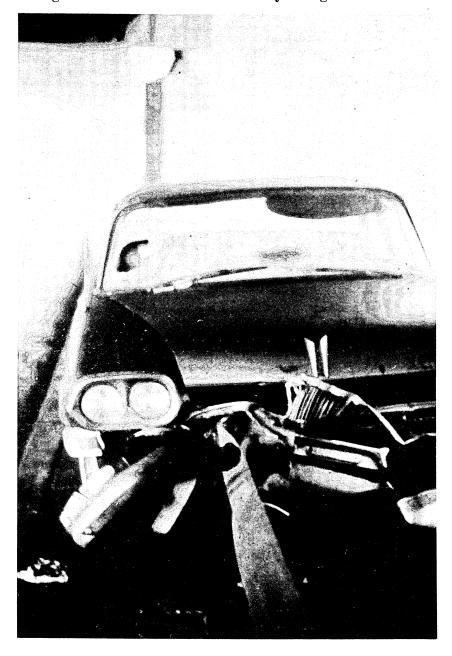
This is the same location; there was no sliding action, it broke off and they got all that damage.

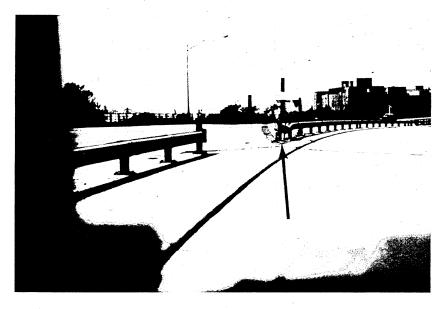
Most of our highways are in this condition. You leave the road, slide along the guardrail, and you have run into the end of the next section of guardrail.

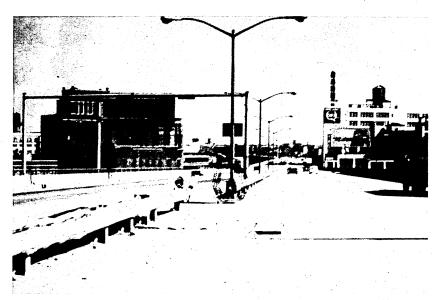
Here you see this pole right in the center of the median. Anyone sliding along this guardrail will slam right into that pole.

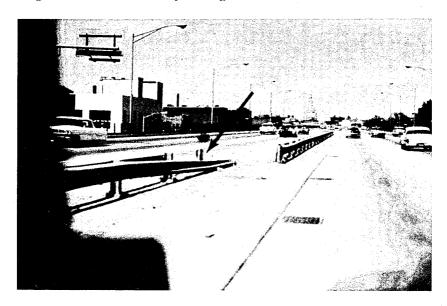
Here you see a pole. Notice the truck in the background. If he comes down and rides along that rail, it is impossible not to hit that pole. All the forces are against him. You have gravity, and centrifugal force to throw you right into that area. It is impossible to steer out of it. If the guardrail were installed properly here he could be guided right past it. We have failed in hundreds of locations on our highways to line up this guardrail properly. It would not cost any more; it is just that nobody is thinking about the problems created.

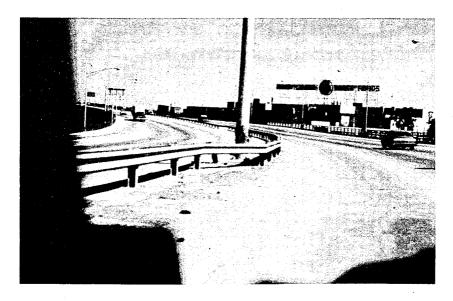
Here you see all these light poles are targets. They are sticking right out. Actually they are designed to be hit if you really look at them. You cannot help hitting them, because they have not been put inside of the center divider.

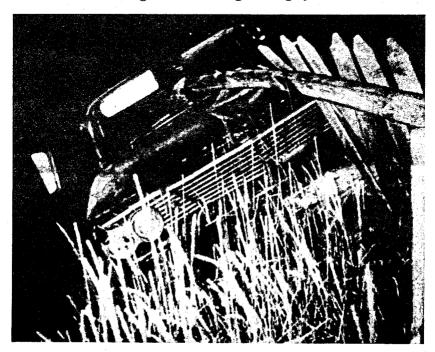
Here are two more views of what you will see all over our highways. All you have to do is just tap these a little and they become great hazards. We should go back to every one of these locations, install a piece of guardrail, and bolt it to provide sliding action.

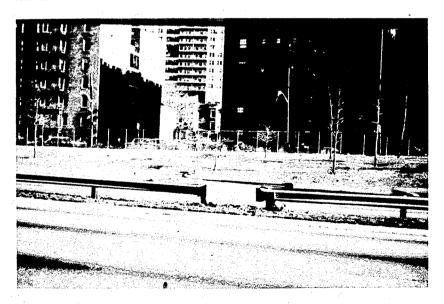
What makes me mad is when I see this. This is a repair job. The rail was damaged and they came by and patched this thing up. All right, so they made mistakes in the past. They did not know any better let's say. But this is what they are doing now, see? This is a brand new work and it is brand new money, and they put it up in sections. Anyone riding along that rail will hit that concrete stanchion, or guardrail end, or light pole because they are still sticking out. I feel it is inexcusable to do things like this.

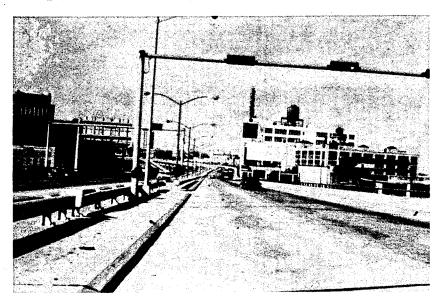
Here also it was not bolted to the railing. Even though it was near it, that means nothing. You have to phase it out, and bolt it to the railing. Instead of getting a scratched fender, a car is badly damaged.

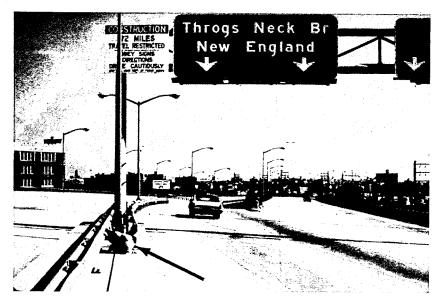
This is what you see. The material is there, but installed wrong.

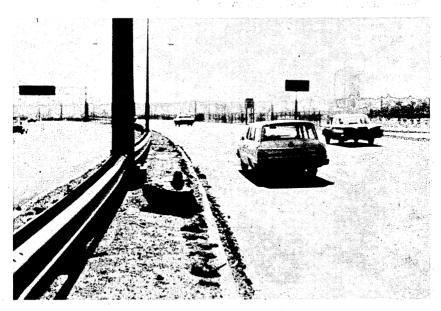
Here you see a steamroller left on the side of the road over the weekend with no markings or anything. Somebody could run into that and get wiped out.

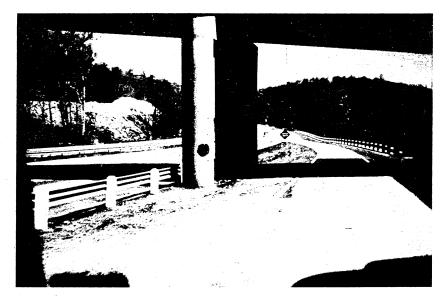
This happens to be underneath an Interstate highway. I feel we created an unnecessary hazard here. Here you see a low curb and many thousands of cars go by here every day. It is a commercial highway and it is in the city. And any car or truck that goes by here, all it has to do is go over that very low curb and it could hit any one of those targets all the way down the line. There are hundreds of them. A 12-inch curb there would give you some protection. The idea is to design the curb originally so you cannot jump it.

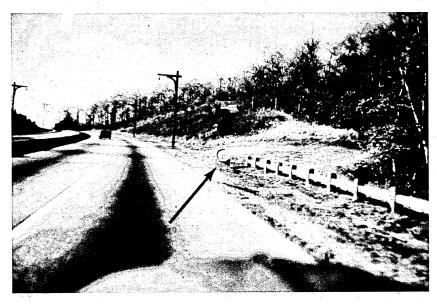
Anyone riding along here gets unnecessary damage because the sand barrels could be put over on the side.

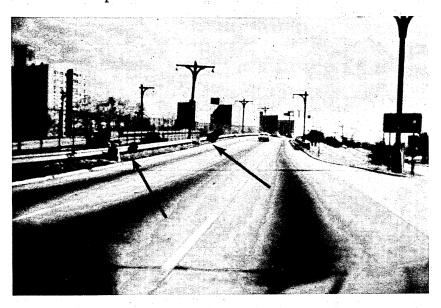
Here you see a large box of sand every year, right in that shoulder area. If you hit that, you stop dead. But they do it every year.
