## HIGHWAY SAFETY, DESIGN AND OPERATIONS Roadside Hazards

Mr. W. May. Mr. Chairman, today we are going to receive an analysis of the Capital Beltway primarily from a statistical and road-side hazard viewpoint. At a later date in the hearings, we shall receive additional testimony on other aspects of the beltway.

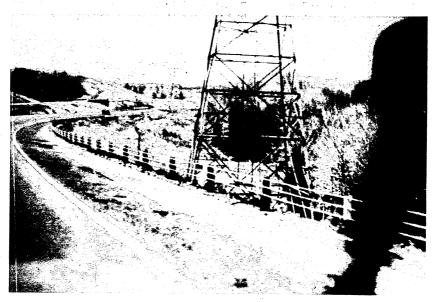
Here you see high-voltage wire towers. Anyone riding over this curb will have gravity to help them go down and they will just cave in that particular installation there and the high-voltage wire will fall on top

of the car. I feel you need a guardrail there. A large truck can roll over the cable.

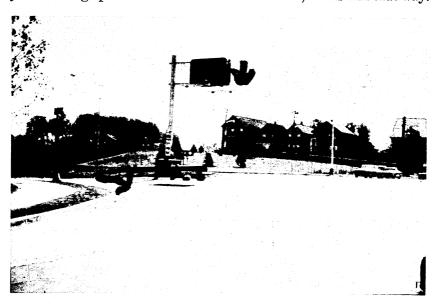
Here you see a sign that says—the arrow is pointing in—it says "Goethal's Bridge." That is actually one way, but that sign is telling you to go in there. I recommended to the State engineers to get that arrow to point down as I have it shown, so at least somebody knows you have to go past it. The last time I looked at it, it was still that way.

They do have a sign on the left, a little sign, saying "do not enter." Maybe it will be foggy and that overhead sign would be lit up there. You would be looking at the lit-up sign and go right in that area. I feel we are asking for trouble.

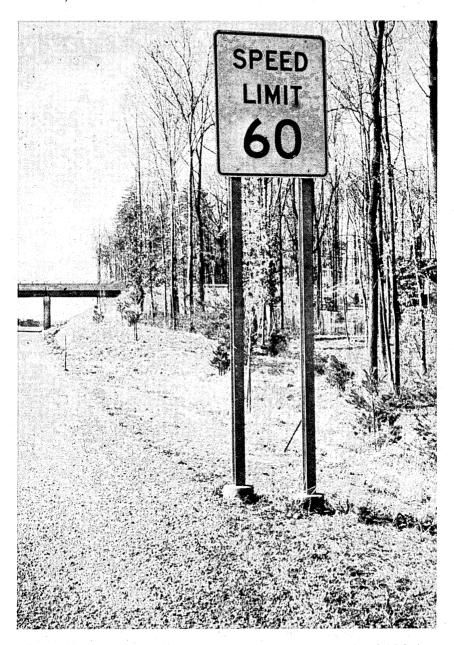
This is a speed sign, which you will find on the Maryland side of the beltway. Again the sign is mounted on two 4-inch I-beams embedded in 3 feet, 6 inches of concrete.

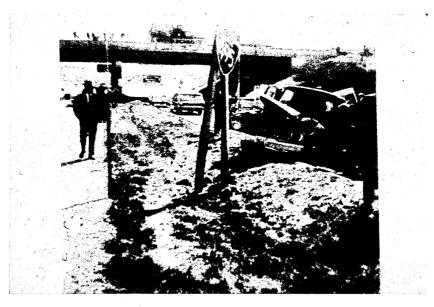
As you can see from this slide, the pickup truck is pretty heavily damaged.

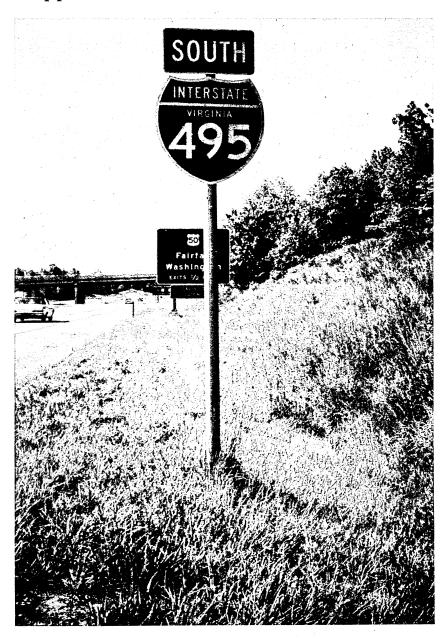
And this is a Virginia speed sign mounted on a 4- to 6-inch steel pipe and embedded in concrete. This photograph was taken from inside looking out across the traffic lanes of the beltway. It is about 2 feet from the shoulder.

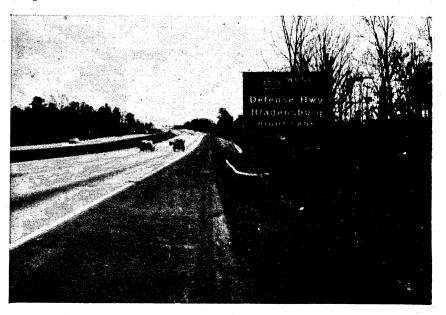
And when I was reviewing the police accident records, I found that there had been an accident at this very location. The driver of this car, a young sailor, was killed. His vehicle got up on the embankment and hit just one of the sign supports, this 8-inch I-beam.

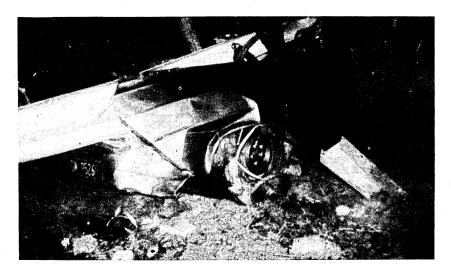
And in April of last year a woman driving on the beltway hit the end of this guardrail. The guardrail went through the front of her car, smashing her windshield, narrowly missing her and came out through the roof of her vehicle extending some 20 feet into the air.

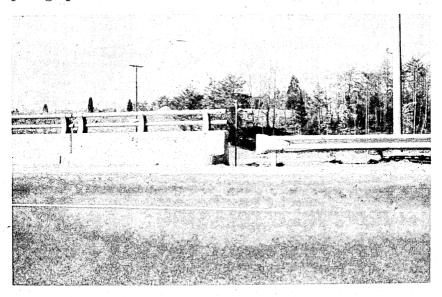
In checking the accident records I found there have been accidents at locations similar to that. This one occurred in December 1965, on the beltway where it crosses University Boulevard. This is in the area just west of the Baltimore-Washington Parkway. This accident resulted in one death and one injury.

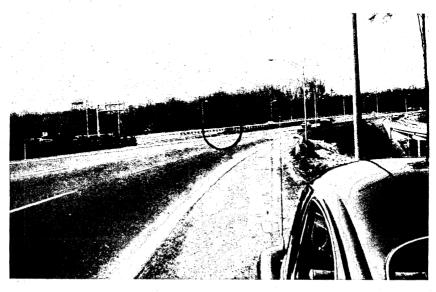
And again checking the police records I found that that location was the scene of a fatality in 1966 where the vehicle smashed into the guardrail and was led into the bridge parapet. I cannot show you a photograph of the vehicle. It was totally demolished and would not serve any purpose at this point.

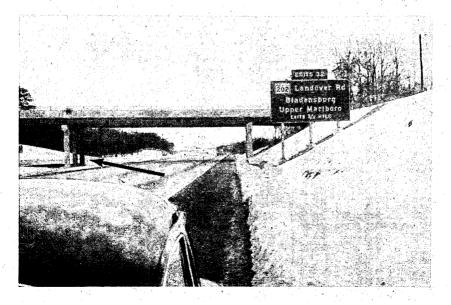
in March and April of this year I found that in September 1965 there had been a fatal accident at the very location which I have just shown you. This occurred at 4:30 in the afternoon. Now this is just illustrative of the type of damage and injury that can be sustained when you hit a bridge pier such as this.

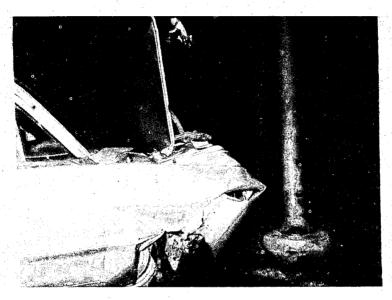
In November of 1965 the doctor driving this car, according to the witnesses and the police reports, was driving at about 50 miles an hour. He hit this light pole. He was killed, and there is his car, broken into two pieces.

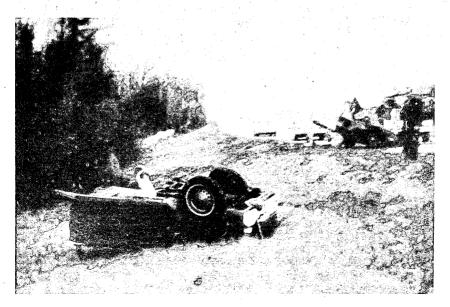
A month later, in December of 1965, again on the beltway, this vehicle hit this light pole. The driver was killed. Damage to the vehicle is evident. Here is the light pole.

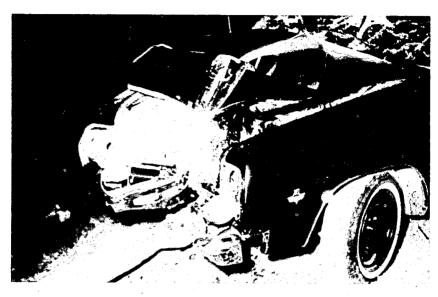
The following month, in March, this vehicle hit this light pole. There is the concrete base, partially out of the ground. One person was killed and two injured.

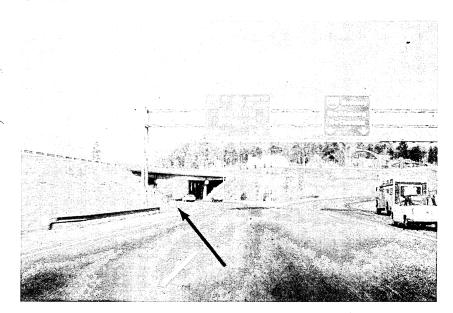
And I found out that in 1964 this steel sign pole and this concrete base had been there. On each side of the roadway that huge piece of concrete we were looking at before was the base for a sign support.

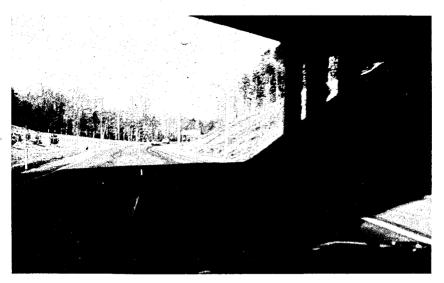
The majority of them occurred from this point to just beyond the 270 route marker. This route marker is mounted on a 4-inch I-beam, and in checking the accident records I found that in April of last

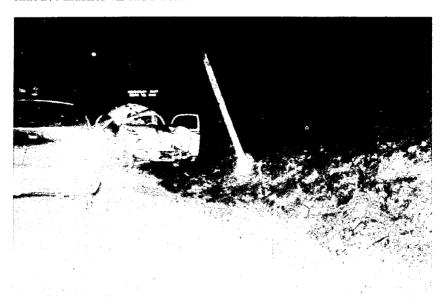
The driver was injured, and again this is what those 4-inch I-beams can do to a vehicle.

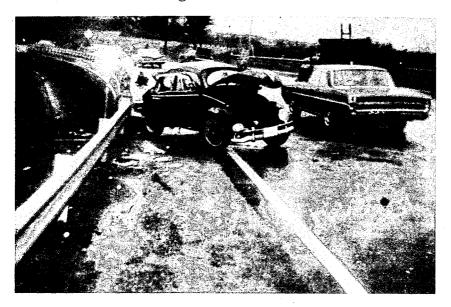
That accident was in November 1966. This photograph was taken in December 1966, 1 month later. This is the way the guardrail was installed after the accident.

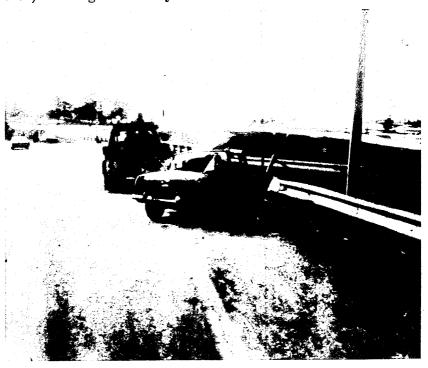
We saw a few minutes ago the other side of the bridge, where the vehicle hit the guardrail and parapet on the right and then came across and hit this parapet here. This photograph was taken in late December or early January of this year. In checking the accident records, I found that in September of 1966 this vehicle ran into the guardrail and hit that same bridge parapet we are talking about, again resulting in a serious injury.

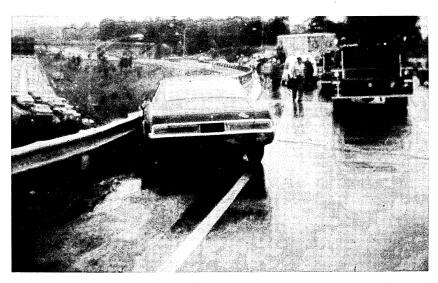
This shows you what happens to the front of a vehicle when it hits one of these bridge parapets. This is the same accident we were just talking about.

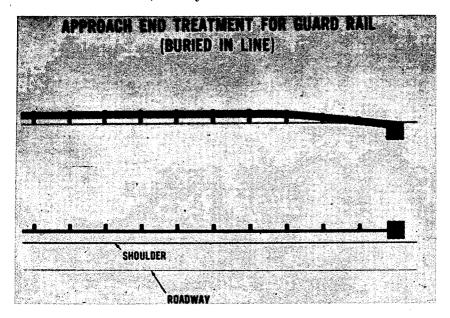
Mr. Prisk. Yes, this is the flared and buried installation, where the approach end of the rail is actually carried laterally away from the roadway, so that your contact is in that curved section before it gets back to the edge of the shoulder.

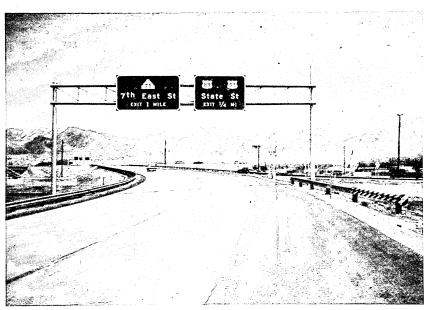
Mr. Prisk. Here is another similar hazard where the rail is there on the approach to the structure, but you have got a pretty good gap there to get through. I don't think you would have to have a small vehicle to get through that gap.

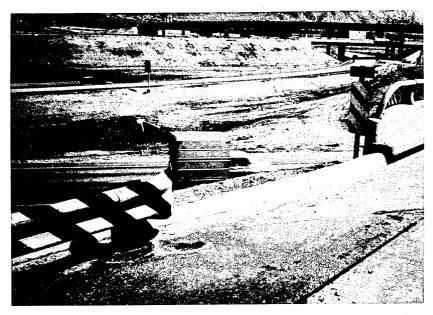
Here is another gap in the rough terrain that I spoke of, between two rails. Originally the contractor used a roadway across here for construction hauling and that section appears to have been left open—is still left open for turnarounds.

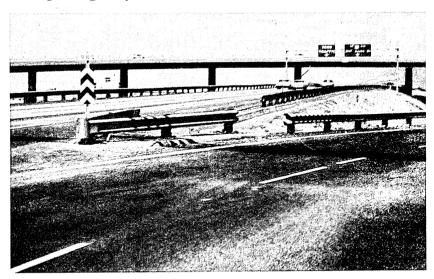
Here you have some discontinuous rail in the vicinity of a decision point, or a gore, as we call it. In this case it is a small section, very short section of guardrail installed here, behind the curb, a short break and on the other side the same thing, again giving multiple chances to failures of the rail.

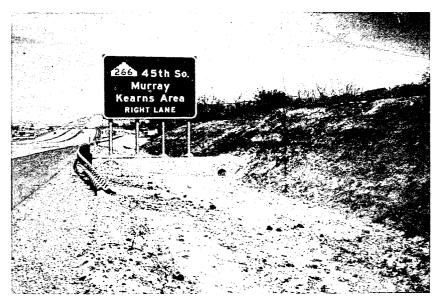
Here you see again about the same kind of situation, rather short run of rail around the sign; no consideration of the hazard presented by these side piers in this case.

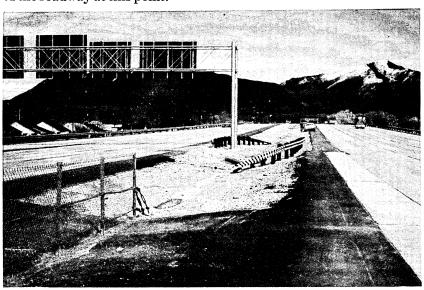
Mr. Prisk. This is the median barrier that Mr. Ricker spoke of. This is a relatively high one we found. This is toward the east end of this Interstate 80 project in Salt Lake. The top of this is 36 inches

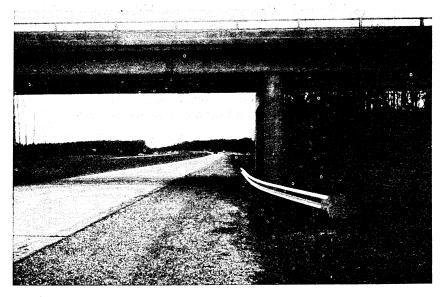
Here is rail lined up with the structure with the exception of the curb that sticks out in front. You see the characteristics we have noted before. The rail is not blocked out. The rail here is set back two or

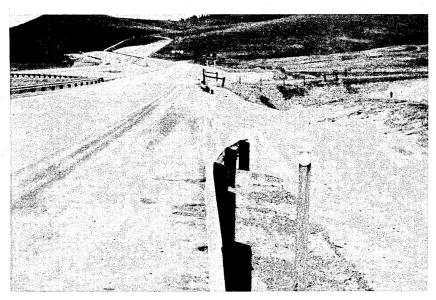
The sections in Montana have something to recommend them because here is the appearance of a washer clearly on a median barrier and this is back in the urban portion, near Missoula, and in this case the rail is not only not blocked out, but the rail is notched into a wooden post. There is an 8-by-8-inch wood post there and the post actually has been notched so it is down to about 5 inches thick at the top.

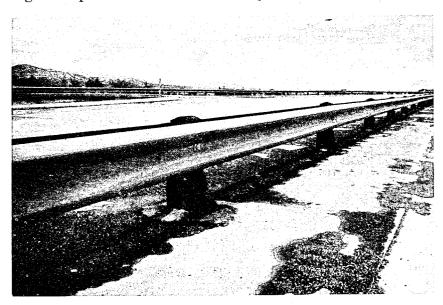
Here is a section on a structure where concrete curb is introduced as you cross the structure and steel posts are substituted for the notched-out wood post and I dare say this is a little better to hit than that other section, from a number of viewpoints.

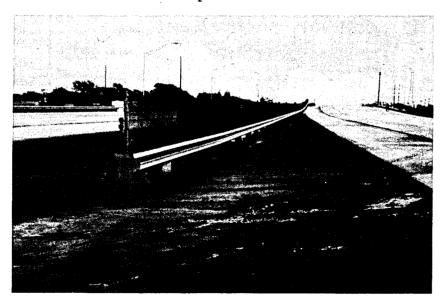
Again, in that terminal section showing there, square posts are used, and the guardrail height here measured at the foot of the post, on the line of the post, is 27 inches, not any too high in that kind of condition.

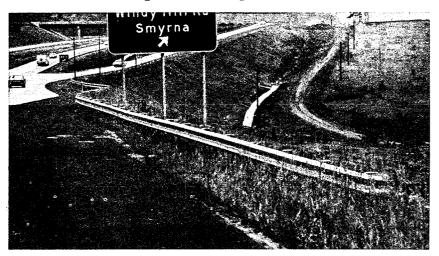
Mr. Prisk. Moving along, here you see as a result of some of this, when you combine it with a deceleration lane, parallel deceleration lane, you get quite a whip in here. You go past the sign, drop the blocks, and follow the line of the decel lane, and you get a pretty good pocket there before you reach the end of that particular installation.
