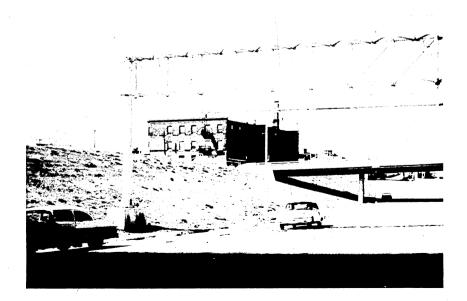
Urban area, off the project, specifically in Kansas City, in the freeway sections that are being built there now. This installation was found with the concrete pedestal supporting one end of an overhead bridge sign.

After some discussion on that job, incidentally, during the course of the visit, some additional negotiation and so on, this work is to be taken down and that hazard will be removed from the gore at that point.

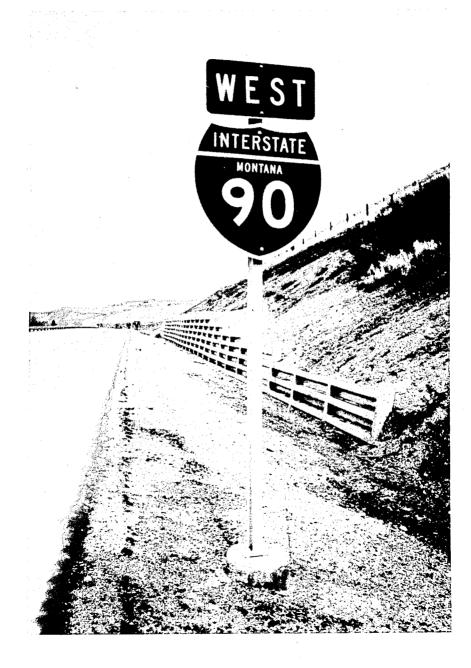
Moving now to Montana, again we find some pretty husky posts here, too. Here is an interstate route marker on a 4-inch I-beam.

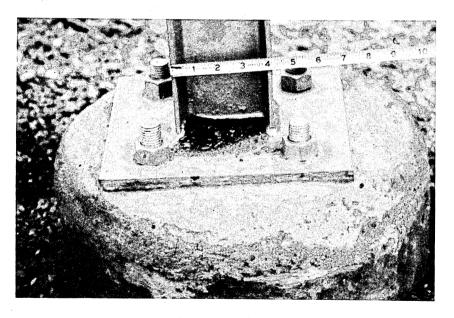
This merging traffic sign is also mounted on a 4-inch ${\bf I}$ -beam on the Montana project.

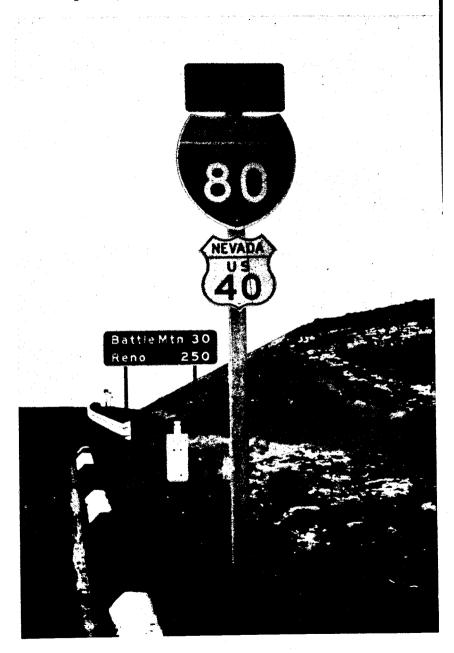
Here it is at night and in a snowstorm—essentially at night—taken with a flash photo. Here you can see the base out of the ground somewhat more than desirable, and the steel post. Both are very close by an asphalt curb.

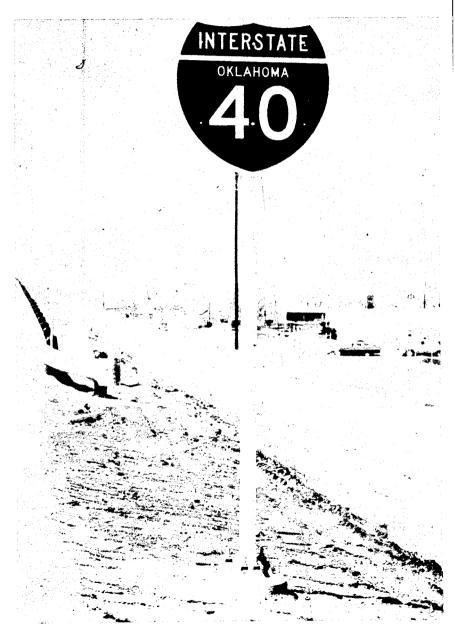
For the first time in our tour we found some breakaway support. This in fact is what your breakaway support looks like down at the base, slip base, this particular design that Oklahoma has adopted.

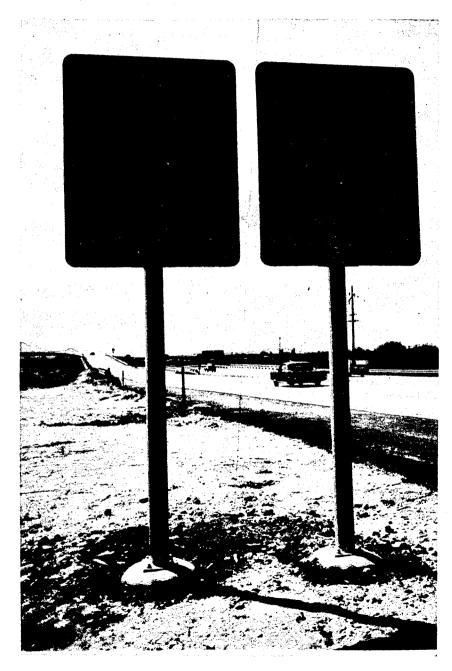
They are up, indicating this is not uniformly controlled to keep these bases down to the ground level.

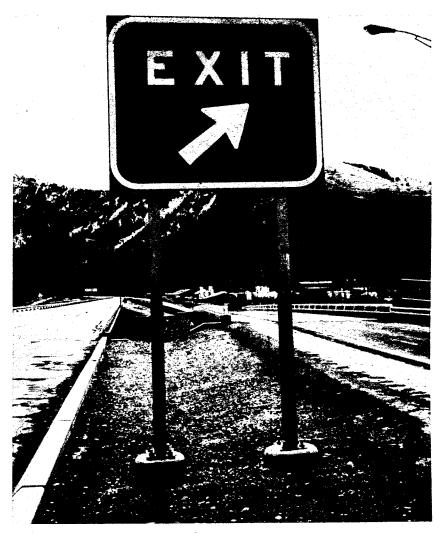
Another gore with a non-break-away sign support, otherwise quite easily traversable up here for several hundred feet if you do run off.

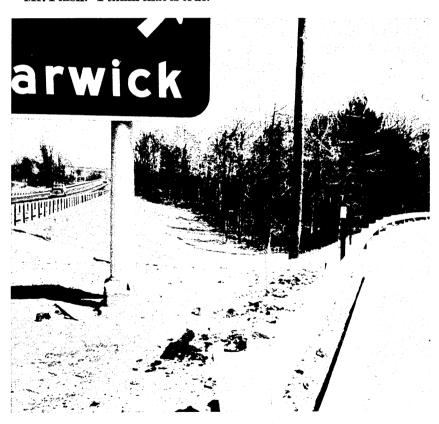
And here we have the gore that you saw as we were looking at signs in particular. This, again, could be relieved entirely by the plan that is now in mind, which is to replace these two structures, both of them having center supports in the gore, with the single structure moved back toward the camera a couple hundred feet.

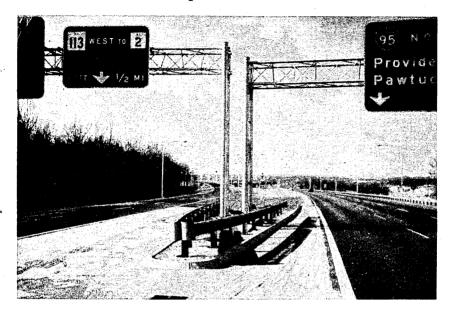
This is a pretty formidable thing to run into.

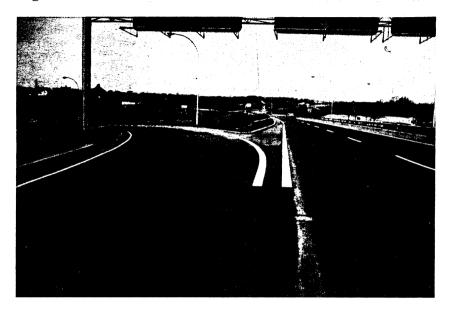
This is a section of gore. This is just off the project, but again a place where a guardrail has been applied similar to the last picture, and it has been struck as you can see.

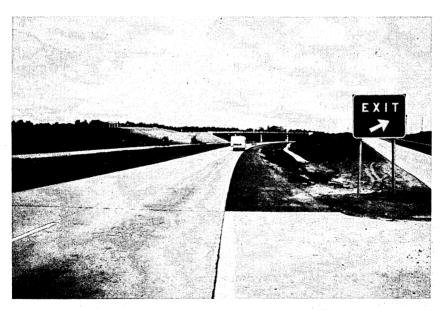
And here, then, at the end of the project, we have this kind of situation where they are getting ready to put up a three-masted sign to replace this Interstate 285 marking, which designates a beltway around the city. A guardrail has been put around the gore area, which constitutes a substantial obstruction.

It too will be a very substantial traffic hazard.

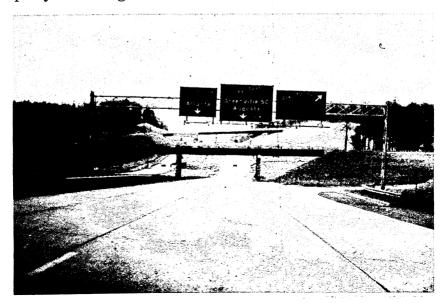
This is the condition headed for the Atlanta Airport, where you have a heavy concrete base here, very short section of guardrail, with two ends to hit. Otherwise, as you can see, it is fairly free and level terrain between the two roadways.

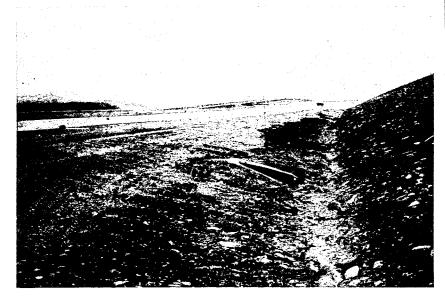
Here is another view of a drainage pipe extending out the side, also in Montana, where there is some hazard involved. It's very close to the roadway.

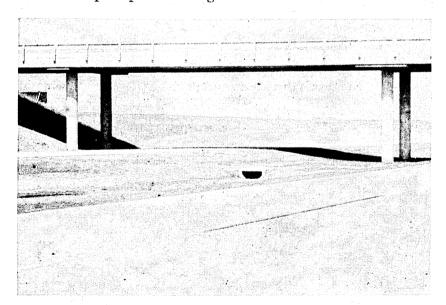
This is a cross drain, again you have a headwall condition, and wing walls there, particularly the headwall. You can well imagine

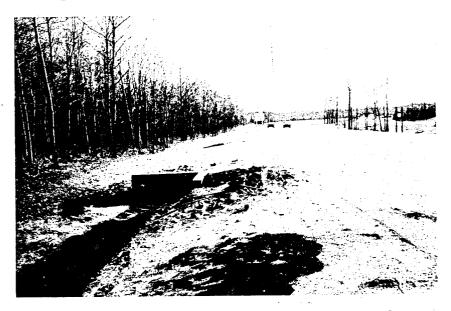
Here is the type of median drain, and an obstruction at the same time, seen on the Georgia project. This is going through a grade separation structure. And although the headwall has been cut off, there still does remain here a less than desirable facility for drainage, from the safety standpoint.

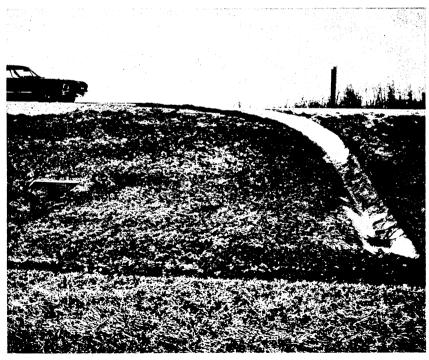
And here is an interesting drainage condition, also found on that project, where there is a ditch paved down the slope which, of course, is not unnatural, but up at the top there is a drop inlet at the same point, which [slide] going back to the previous slide for a moment, the outlet is at this point [slide] so you have two places for water to go immediately in front of that automobile.

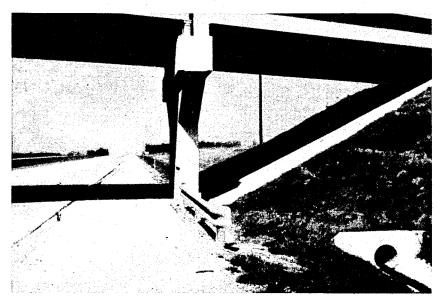
Mr. Constandy. Also undesirable, that headwall? Mr. Prisk. It presents a very, very solid hazard.

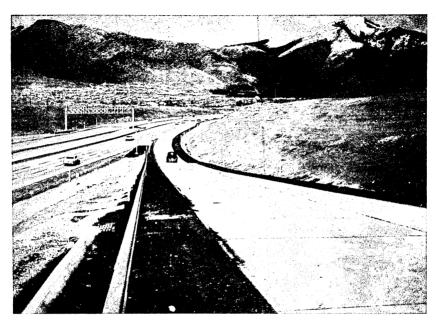
Here, too, is a similar condition which shows how the guardrail gets warped at this point, even though we have a shoulder provided on the bridge. There is no shoulder commensurate in width provided back in this area. [Indicating.]

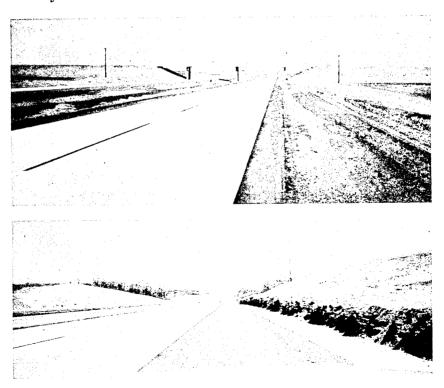
A special situation, of course, introduces itself if you find rock alongside, and in the severe cases here this has been cut back to 20 or 25 feet from the pavement edge, still stands there, somewhat of a hazard.

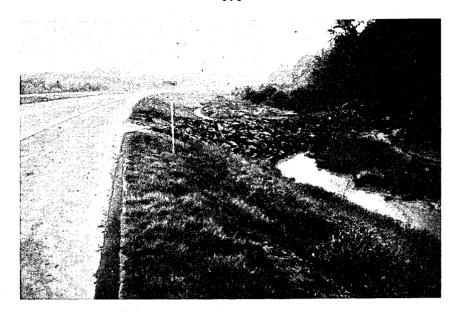
On the roadside slopes are moderately good, but you find conditions of this sort where water is dammed up.
