#### 1.12.5 Impact Attitude Determination

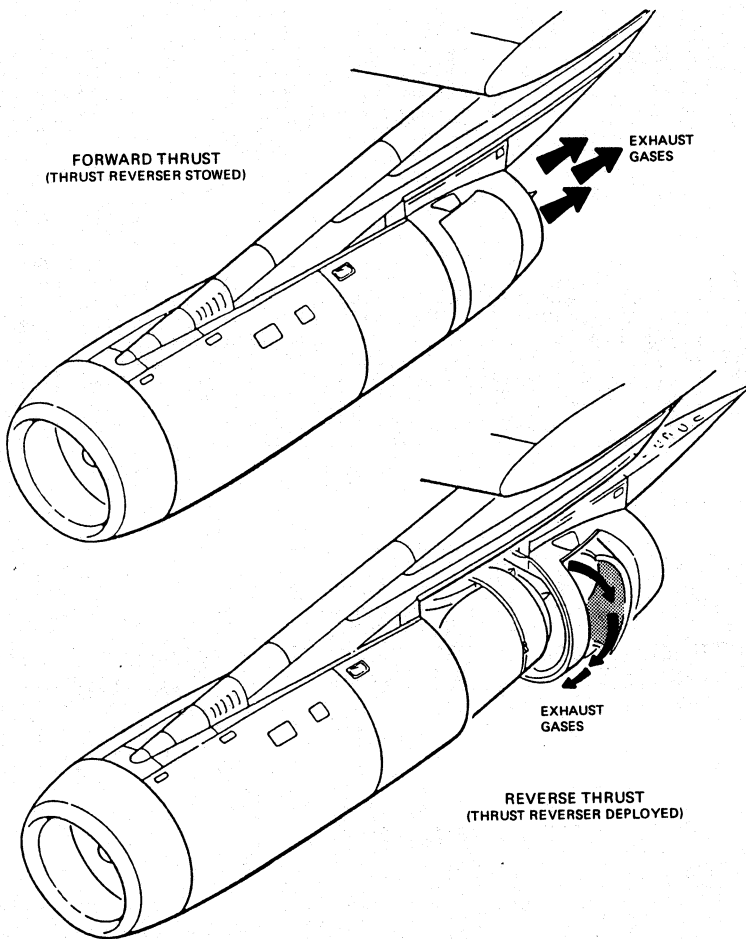
Figure 1.7. Schematic of Thrust Reverser Assembly

The number four reverser assembly had separated from the exhaust nozzle at impact. The forward loop of the translating ring assembly was broken with pieces missing from both sides. The lower deck was twisted 180 degrees around the rear section of the ring so that the forward face of the upper part of the translating ring was at one end of the assembly and the forward face of the lower portion was at the other end. The outboard deflector door was trapped by the structure in the faired position at the lower hinge point. The metal skin in this area was deformed inward, trapping the actuating arm in the faired position. The upper actuating arm for this door was torn away from the translating ring, but there were clear witness marks on the slot edge showing that the arm was in the faired position at the time this damage occurred (Figure 1.8.). The inboard deflector door was torn away from the upper attachment point and was twisted to the deployed position. There was moderate to heavy damage to the forward edge of this door. There were deformed areas to the aft end of the actuating arm slots at both the upper and lower hinge points, evidence that the actuating arms for the inboard deflector door were also in the faired position at impact (Figure 1.9. and Figure 1.10.). The lower track was severely twisted but remained attached by the slide bracket to the forward edge of the translating ring. The slide was within 12.5 inches of the forward position and could not have slid forward after this impact deformation had occurred (Figure 1.11.). The hydraulic actuator was near the forward end of the piston rod. The outer cylinder had split lengthwise, with the material around the split bowed out (Figure 1.12.). This evidence was consistent with rapid extension of the actuator by external forces, and further confirmed that the translating ring had been in the forward position at the time of ground impact. It was concluded that the number four reverser was in the faired position with the translating ring in the forward (stowed) position at ground impact.

No failures were noted in any of the four reverser systems other than those resulting from impact.

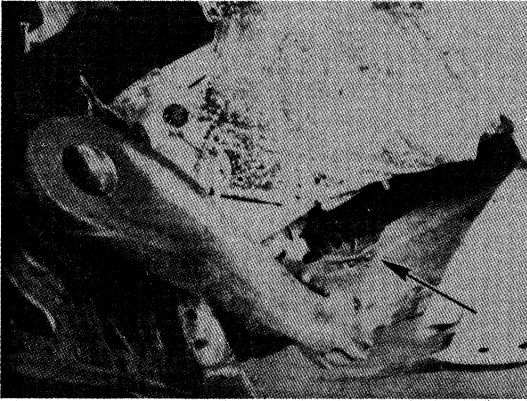
*Figure 1.8. Number Four Thrust Reverser Outboard Deflector Door Upper Actuating Arm Area*

OUTBOARD DEFLECTOR  
DOOR UPPER ACTUATING  
ARM AREA OF NO. 4  
REVERSER. ARM HAS BEEN  
PULLED OUT OF SLOT BY  
CRASH DAMAGE. NOTE  
DAMAGE IN AFT END OF  
SLOT AT ARROW.

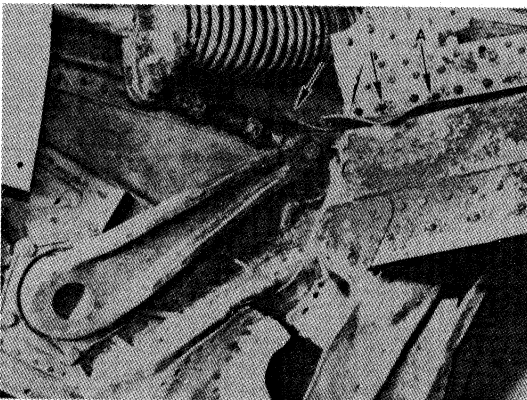
*Figure 1.9. Number Four Thrust Reverser Inboard Deflector Door Lower Actuating Arm Area*

THRUST REVERSER NO. 4  
INBOARD DOOR LOWER  
ACTUATING ARM. SKIN HAS  
BEEN CUT AND FOLDED  
BACK TO SHOW  
DEFORMATION IN EDGES OF  
SLOT (ARROWS). NOTE THAT  
ARM IS IN THE DOOR  
DEPLOYED POSITION.

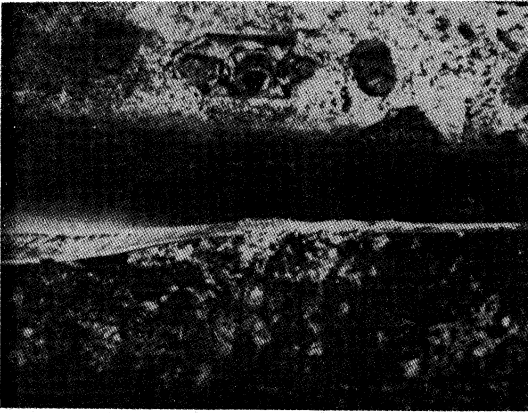
*Figure 1.10. Number Four Thrust Reverser Inboard Deflector Door Lower Actuating Arm Area*

VIEW OF DAMAGE TO EDGE OF SLOT AS SHOWN IN FIGURE 1.9. AT A. DAMAGE PATTERN SHOWS ARM MOVED FROM THE DOOR FAIRED TO THE DOOR DEPLOYED POSITION AFTER INITIAL IMPACT.

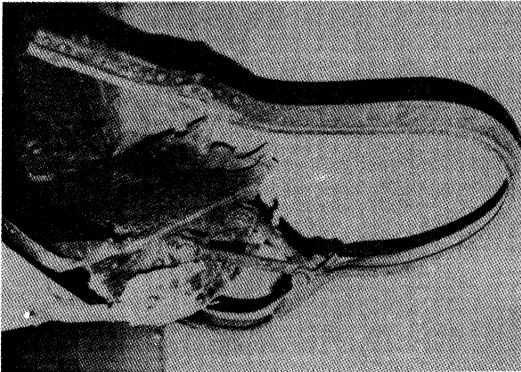
*Figure 1.11. Number Four Thrust Reverser Lower Track*

THRUST REVERSER NO. 4 LOWER TRACK. AFT END OF TRACK IS AT TOP IN PHOTOGRAPH.

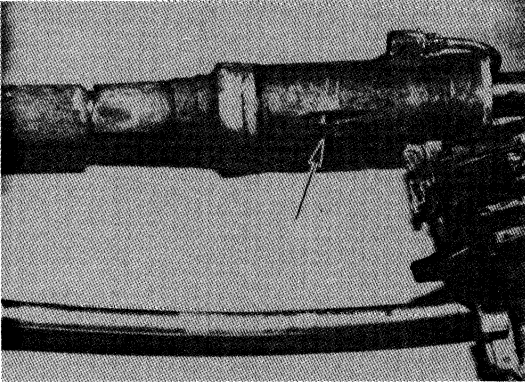
*Figure 1.12. Number Four Thrust Reverser Hydraulic Actuator*

THRUST REVERSER NO. 4  
HYDRAULIC ACTUATOR.  
NOTE SPLIT IN OUTER  
CYLINDER.

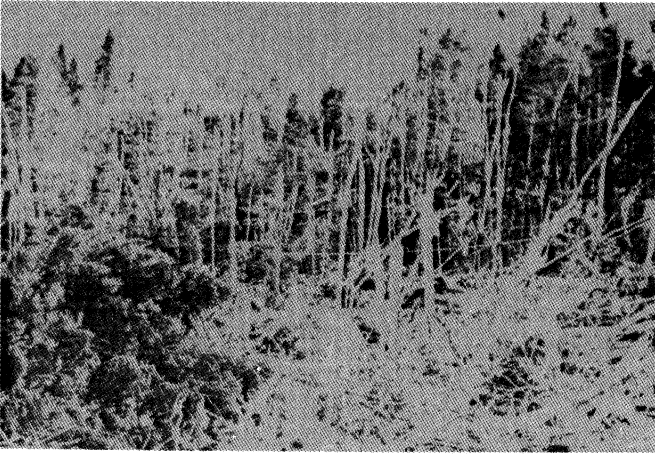
*Figure 1.13. Photo of Tree Swath Cut by Aircraft*

Using analytical plotters, three dimensional measurements were made of 378 trees which had been cut by the aircraft prior to ground impact (See Figure 1.13.). A 1/100 scale model of the tree-cut zone was then constructed, and a detailed 1/100 scale die cast model of a Douglas DC-8-63 aircraft was mated to the tree pattern (See Figure 1.14.). Flaps were placed on the model at an 18-degree configuration to match post-crash investigation findings. By accurately measuring the orientation of the aircraft model in the tree pattern at increments along its flight path, the attitude of the aircraft and the flight path angle were determined. Measurements indicated that the aircraft first contacted the tree canopy in a seven-degree right bank, nine-degree pitch (the angle between the longitudinal axis of the fuselage and the horizontal), and a 10-degree yaw right attitude, on a descending, 12-degree flight path angle (the angle between the flight path and the horizontal).
