Sewer Infiltration Investigation - Borough of Far Hills

**CFM INCORPORATED**

June 8, 1983

Re: SEWER INFILTRATION INVESTIGATION - BOROUGH OF FAR HILLS

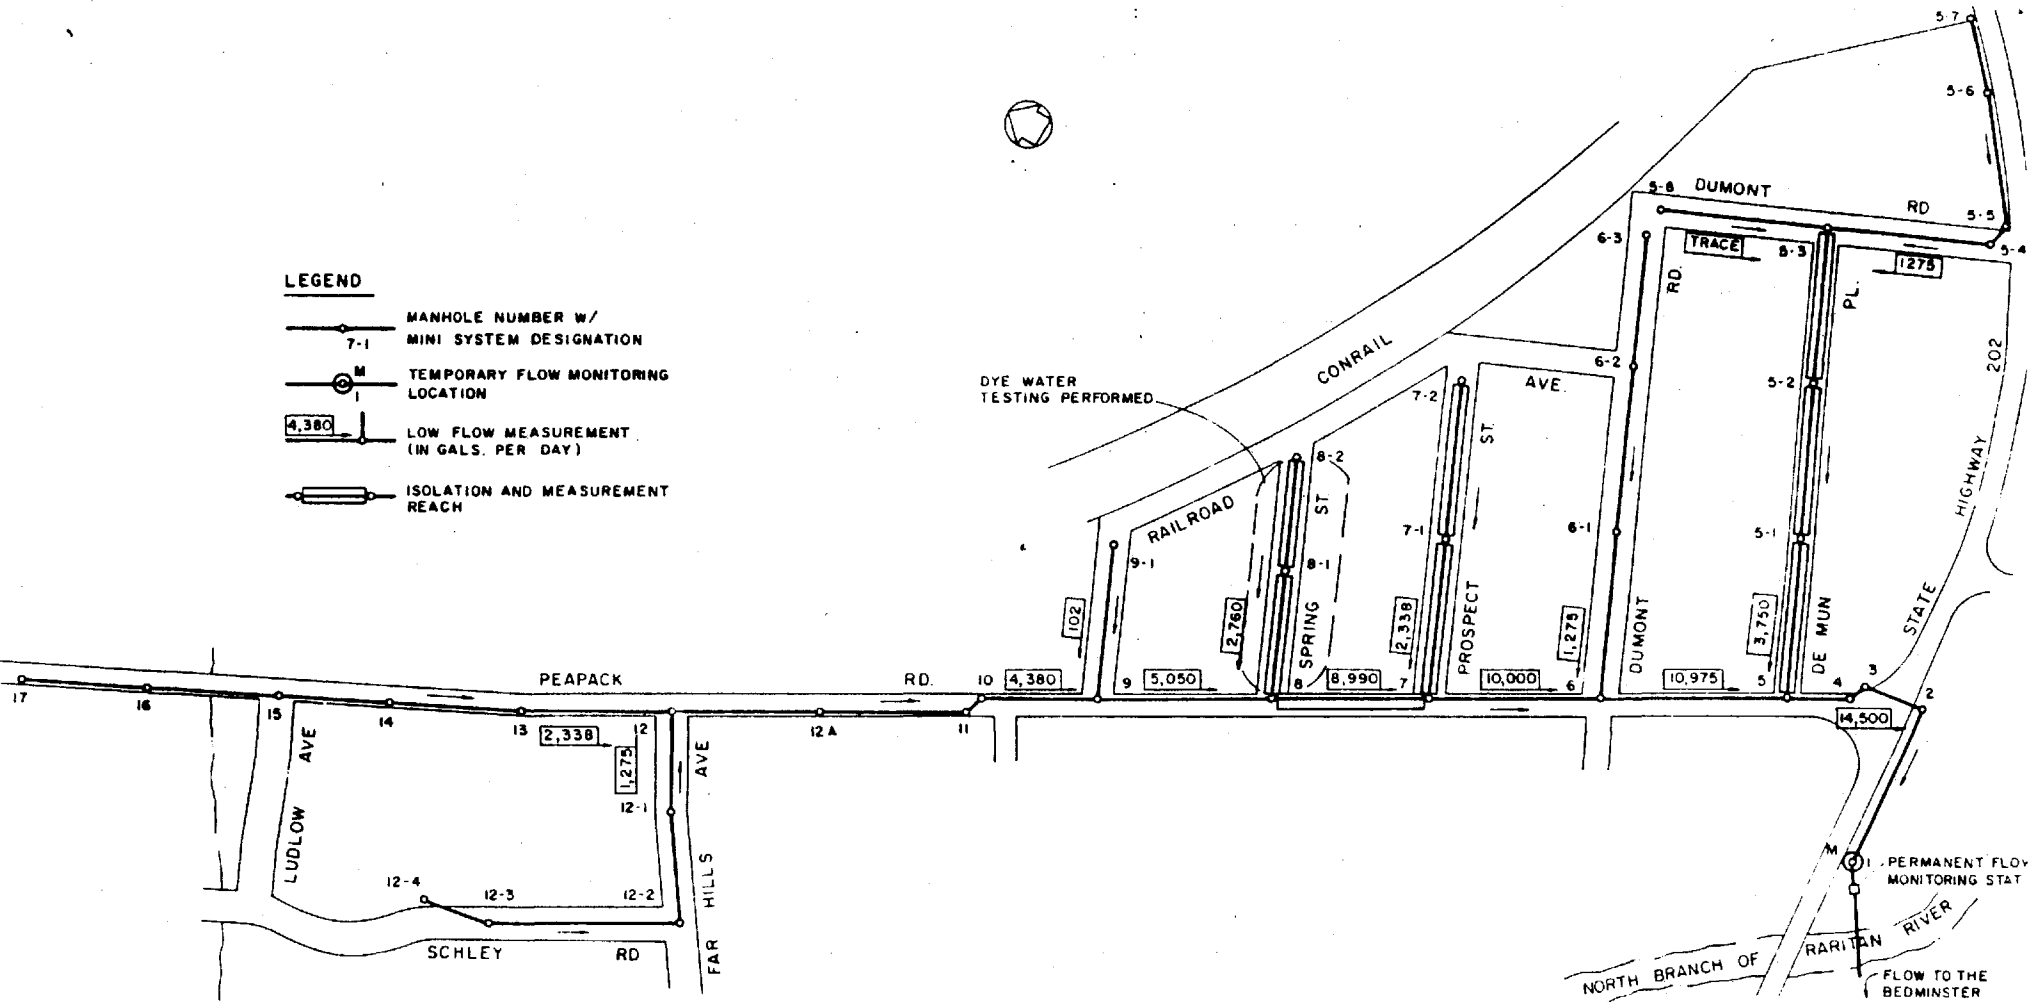
PLAN

The attached plan shows the Borough's sanitary sewer system with manholes assigned specific numbers for ease of identification. The plan also shows the results of the low flow measurements obtained on May 13th. The measurements were made in key manhole junctions in the system to identify those branches contributing leakage. Evaluation of the measurements obtained (considering the size and dimension of the sewer system upstream of the point of measurements), identified segments of the system to be investigated further with flow isolation techniques. Segments of the system that did not contain infiltration in a significant quantity were not investigated further. Of the total continuous infiltration to the system, approximately 70% was found to occur in nine segments (about 1900 L.F. of pipe). The length of these segments represented about twenty four percent of the total footage of the system, suggesting that the infiltration is not widespread but confined to specific locations.

- b. About seventy percent of the leakage was confined to about twenty five percent of the piping system, specifically around De Mun Place, Prospect Street, Peapack Road and Spring Street.
- c. The sewer on Spring Street contains a direct connection between the sanitary and storm sewers that contributes flow continually to the sanitary sewer and possibly significant flow during rainfall.
- d. About one third of the manholes in the system presently contribute some degree of leakage (as seepage).
- e. About one third of the manholes in the system may contribute inflow during storm events, especially through low-set covers and around the frames.

- a. Approximately 1400 feet of pipe should be inspected by internal television equipment. The sewers should be cleaned before the inspection to insure that the vision of the camera is not obstructed. Further, the sewer should be inspected at a time when flows are low enough to allow unobstructed view of the piping system and source of infiltration. The attached table shows those sewers to be inspected. These were selected by utilizing a minimum infiltration rate of 3000 GPD/in-mi as a basis. This value is a common limit utilized by the USEPA in evaluating sanitary sewer systems.
