*Launch Complex 39 liquid oxygen propellant system*

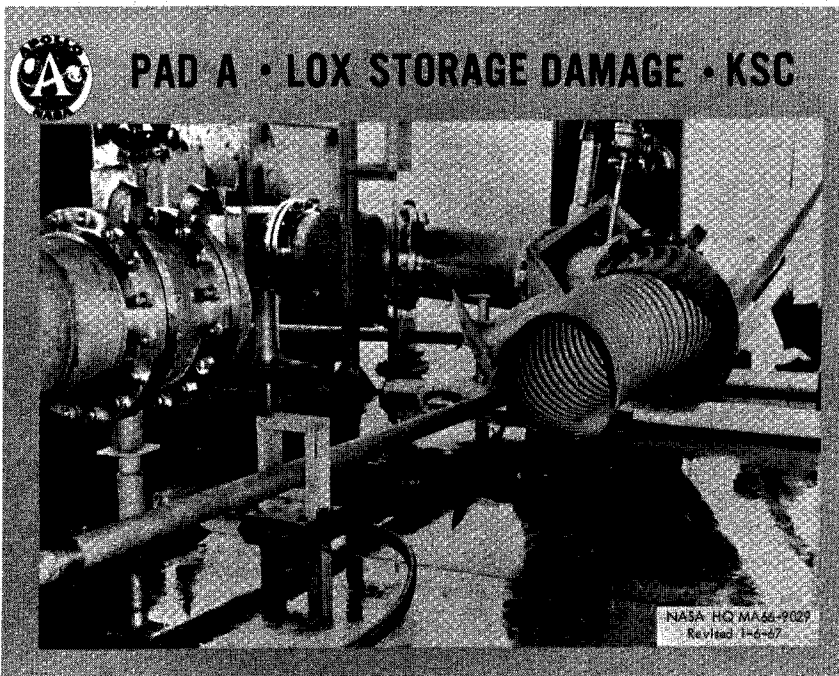
FIGURE 53

A flexible section of an 18-inch liquid oxygen transfer line ruptured during a Pad 39A facility checkout test in August 1966. The tank inner shell dimpled from low internal pressure resulting from the liquid oxygen discharge. The liquid oxygen discharge also displaced piping and caused minor damage to the tank foundations and nearby machinery (fig. 53, MA66-9029).

All damage was repaired and modifications to the system were made to prevent a recurrence. The complete repair, modification, and tank refilling was accomplished in approximately one month.
