# LOSS OF BONE DENSITY ON GEMINI MISSIONS PART II

# GEMINI BONE DENSITOMETRY STUDY CHANGE IN DENSITY OF HAND PHALANX 5-2

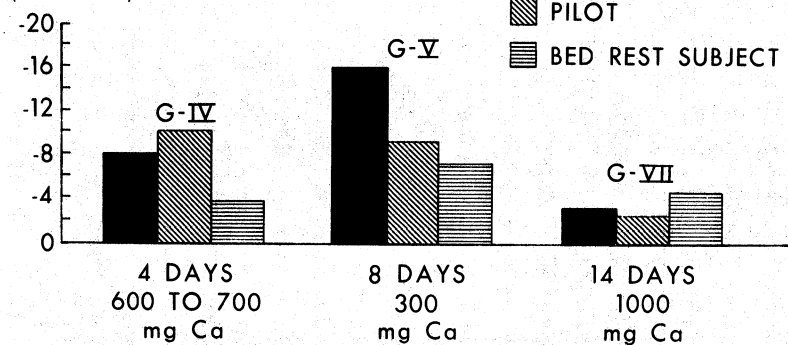
FIGURE 26

CHANGE  
IN OS  
CALCIS  
DENSITY  
(PERCENT)
