FIGURE 30.—Infrared imagery of a portion of Texas City showing thermal effluents.

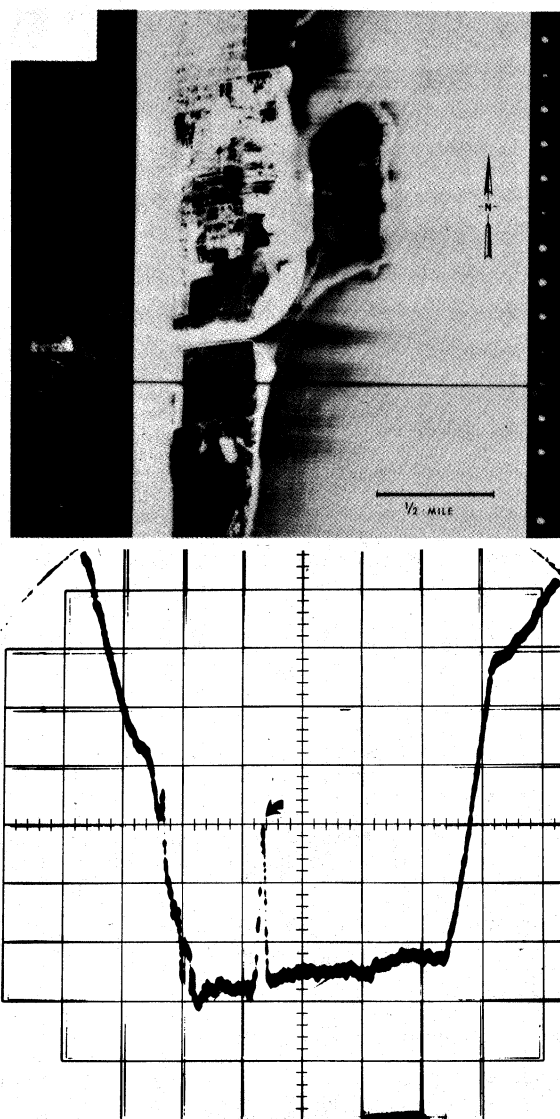
Upper : Part of aerial infrared photograph showing two thermal effluents (white).

Black line shows location where temperature profile in lower picture was made.

Lower : Typical temperature profile obtained from infrared photograph. Black line represents temperature across the picture above. Note sharp spike at location of thermal effluent.
