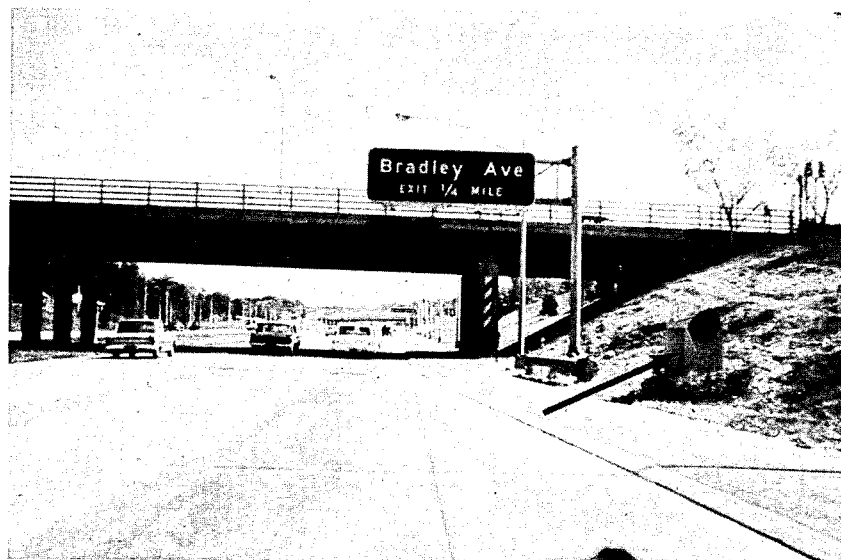
Here you have it on the right. In fact, you have three separate hazards here.

Mr. BLATNIK. May I ask, Mr. Prisk, here we have the same highway department, the same installation of the electrical transformer near a bridge. Each of these three are located at a different spot. One is right in line with the light pole along the edge of the highway; the other one directly behind the protecting guardrail near the bridge; and the third is off, not quite along, the shoulder; yet not as far back into the slope as it should be to be safe. Why the disparity in location?

Mr. PRISK. I think that the only honest answer I can give to that question, Mr. Chairman, is that there is failure to recognize that transformer box structure as a potential hazard. And not recognizing it as a potential hazard, these transformer boxes, or installations, were probably made on the determinations of electrical engineers and lighting engineers on the basis of the circuitry. They run so many hundreds of feet, so many thousands of feet, and put in a transformer, or so many pole installations and drop a transformer in. And they come more or less by chance on the highway on the basis of that type of reasoning.

Mr. BLATNIK. Here we have three possible points of impact, the concrete block housing the transformer to the right, the sign post for the sign, and the guard rail. Then beyond it we have the bridge support, vertical support.
