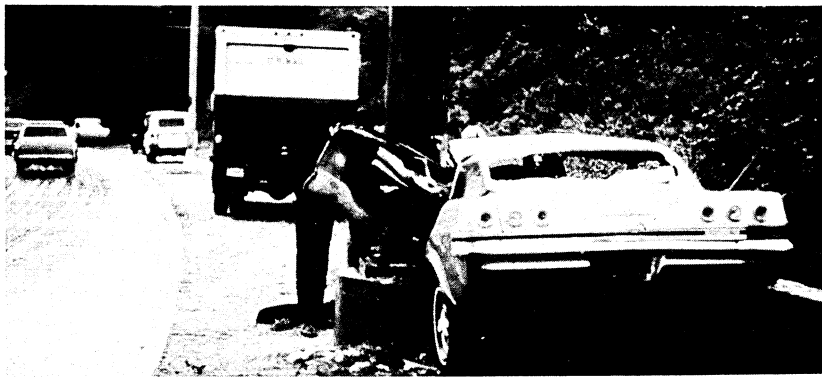
Mr. LINKO. Yes; same location. This has been hit prior and the guardrail was never replaced.

Mr. LINKO. It is a wall, a stone wall. This stanchion could have been put behind the wall, or on the stone wall like I showed before. It happens to be a usable shoulder area, and this is the place where a car most likely will run off the road. It is on the outside of the turn, and it was raining. Failing to replace the guardrail caused the unnecessary hazard to this person.

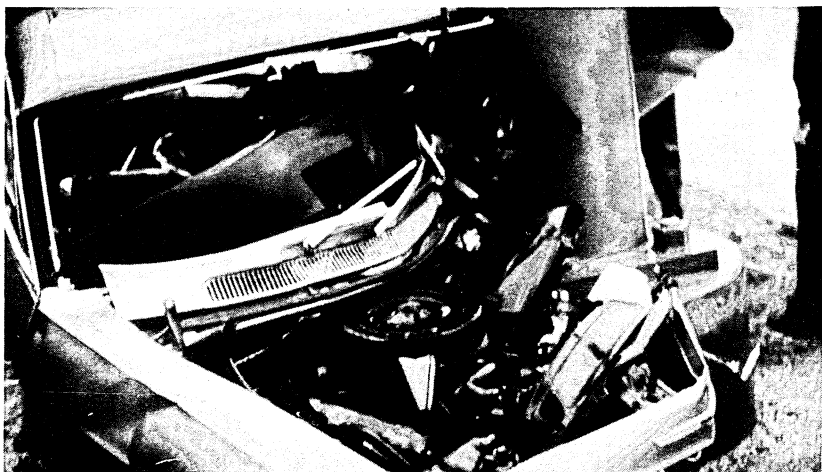
Suppose you had been sitting where this driver was?

Mr. BLATNIK. Same pose, same vehicle, front view?

Mr. LINKO. Yes.
