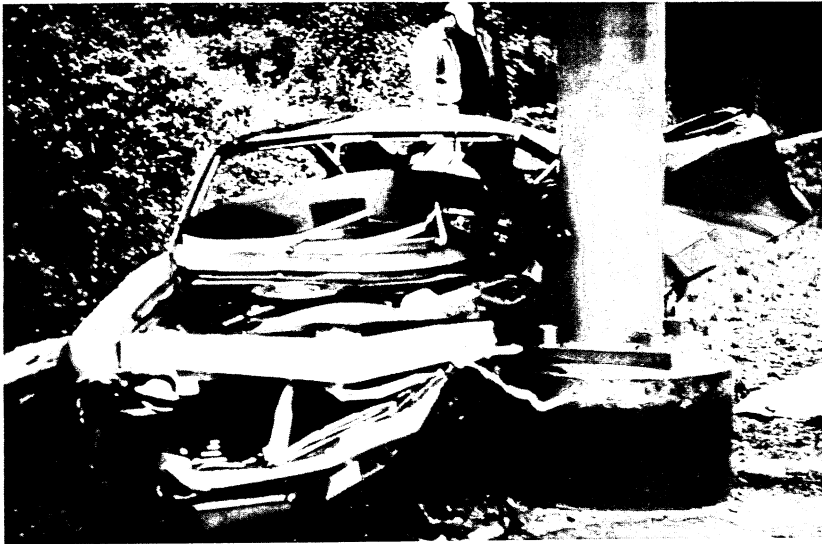
This is what happened. I feel this is really unnecessary because this pole could have been out of the shoulder area and on top of the wall.

This shows the terrific damage, unnecessary damage that is caused on your highways because of making simple mistakes.

Mr. LINKO. Sometime they might put up money to back these things up so it can be cleared from the shoulder. In this particular case, that is just a little stretch, about 3 or 4 feet. Why are they permitted to saturate the shoulders? If you have a shoulder area, these stanchions are supposed to be 2 feet off the shoulder area.
