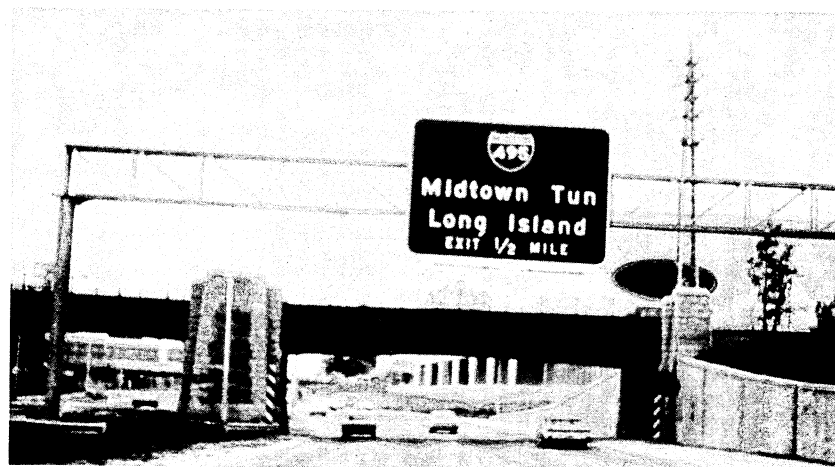
bridge abutment, then we add a couple of sign supports to create additional hazards. Now we are going back to correct the initial mistake of the initial abutment; we are going to put some guardrail in. Then we should look to see how better we could place the guardrail. The guardrail could have been drawn back here (fig. 1-063) and ended up protecting the motorists from this concrete pedestal on the right sign support.

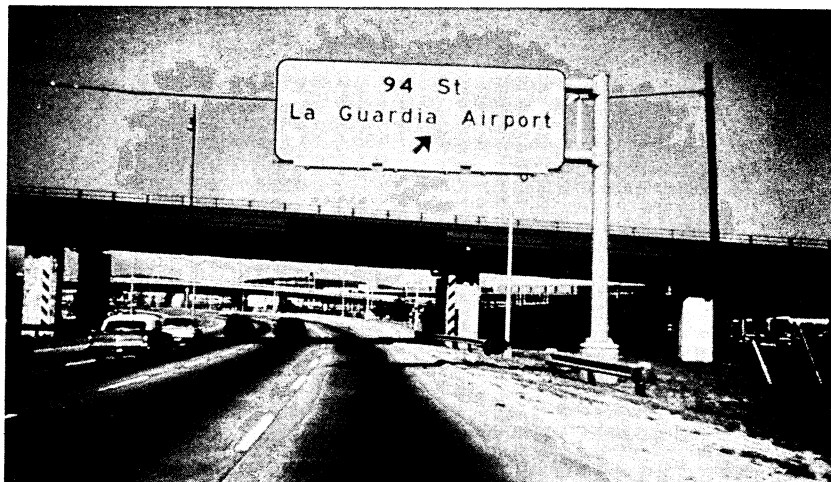
And here you can see another sign that could be put on top of an overpass, and that is not going to look bad. You will notice the marks; I want everybody to concentrate on the marks, because they
