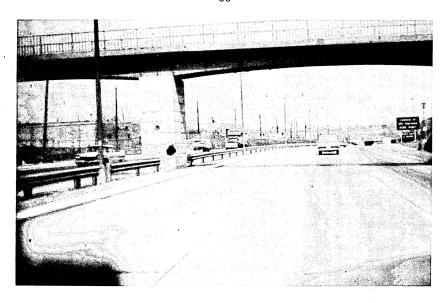
jumps that curb and slides along the guardrail has to slide into the abutment.

That guardrail could have been alined so that as you slide by, you could pass that abutment. Just because they call it a "center barrier" does not mean it has to be put in the center of that pole.

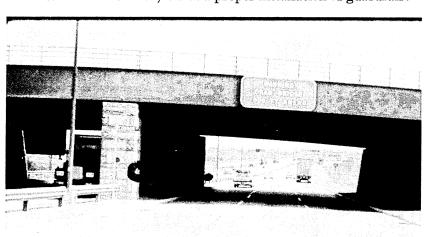
And here you see another picture of the same deficiency. Besides that, I want you to notice all the dots on there. Every one of those dots is a potential hazard somebody could snag onto there.
