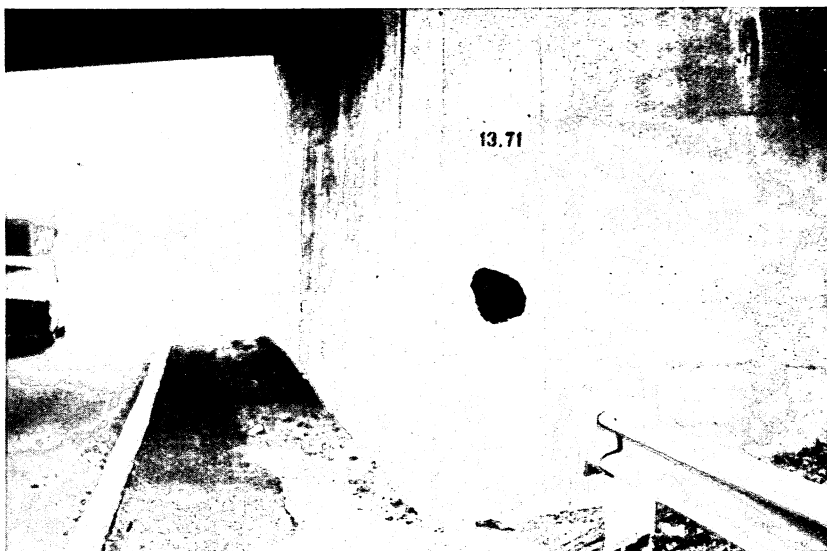
If you look close, you can see a scratch all along there, where a bumper hit this. They repaired it and put it right in the same place. This is wrong.
