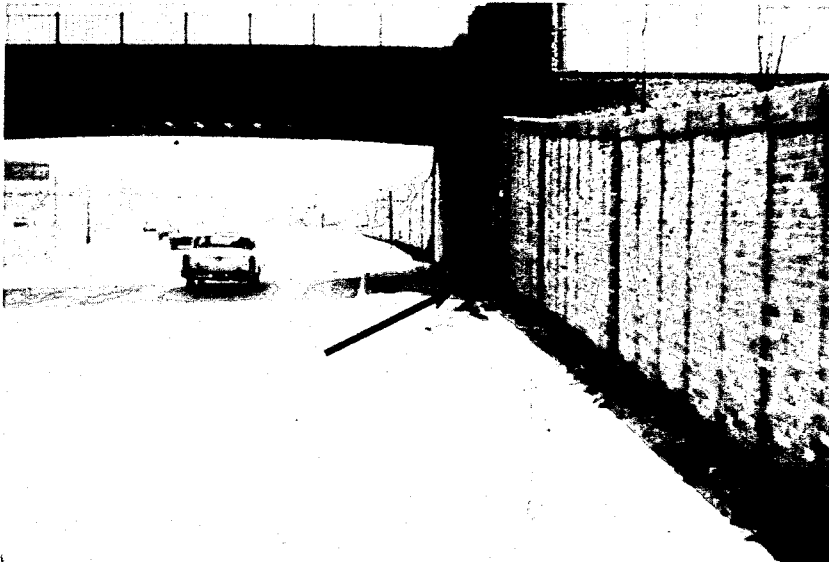
Now, this slide shows you some car did hit this area and knocked that warning marker down. If you catch it right, you can wipe out a passenger.

This wall should be smooth, but this is the way in New York State they build these things, and they are still building them today.

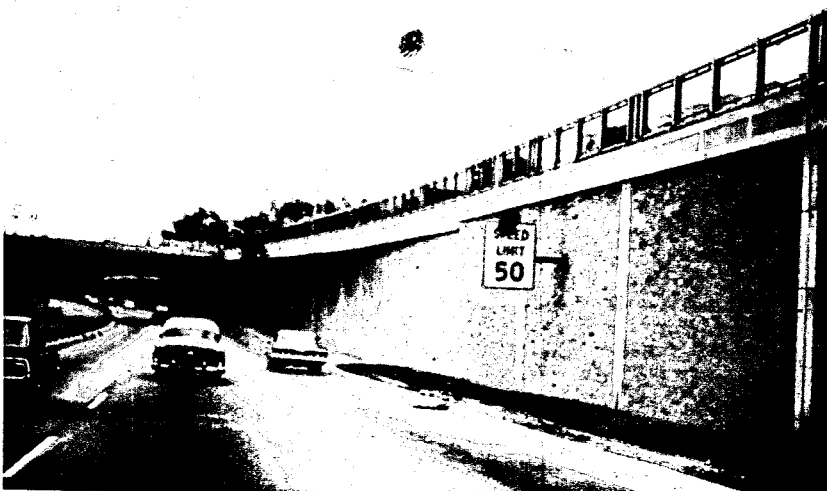
This is the way it should have been done. There is not any reason why you should have any bridge abutment at all, especially on the depressed highway. Here, you see even the sign has been put on the wall.
