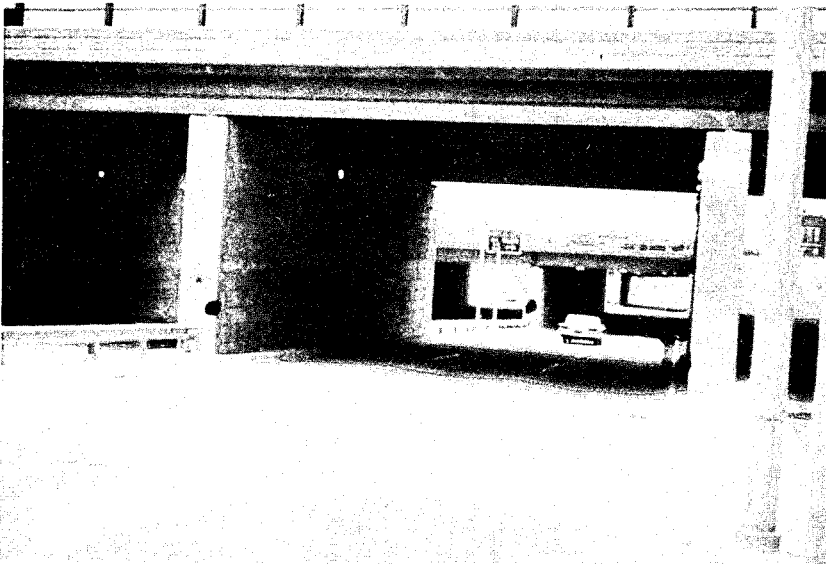
Now, this is a brand new section of an interstate highway. Here on the left the guardrail is installed wrong because you can slide right into the abutment. Notice there are three structures in this one picture.

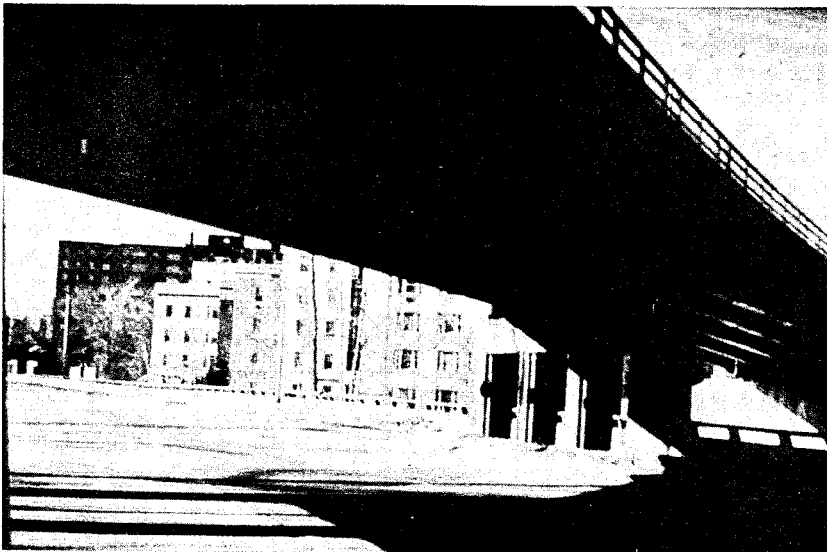
Here is a close-up view of something we were just talking about. You see the fence in between there; the material is there to provide a smooth-sliding action. Someone wasn't thinking; there is a tapered curb there and there happens to be a little turn, and because of that someone is going to have to get wiped out in that spot.
