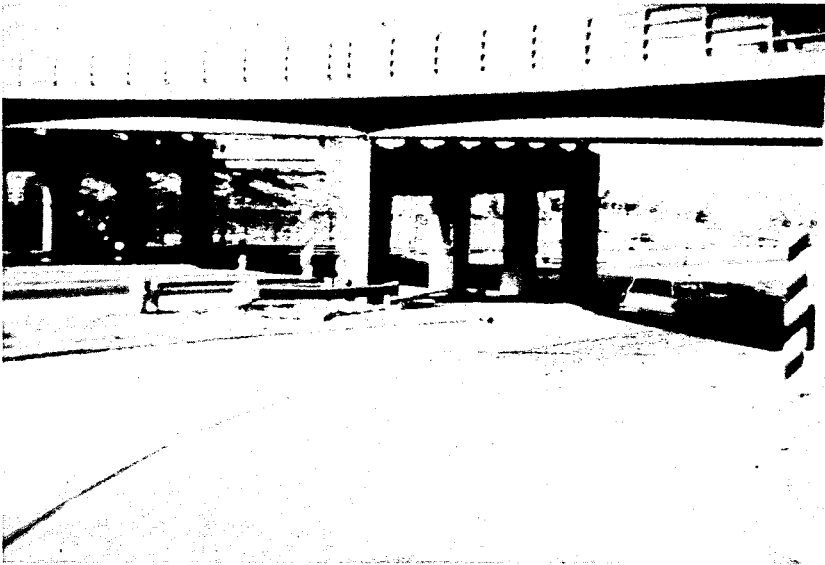
Here you can see the guardrail protecting the first post on a downhill turn, and there is a tapered curb. They must not be interested in the other three posts. That guardrail has been damaged and it is being replaced at this time. They still neglect to see the other three posts, and it was replaced just the way it was before. The rail is too short.

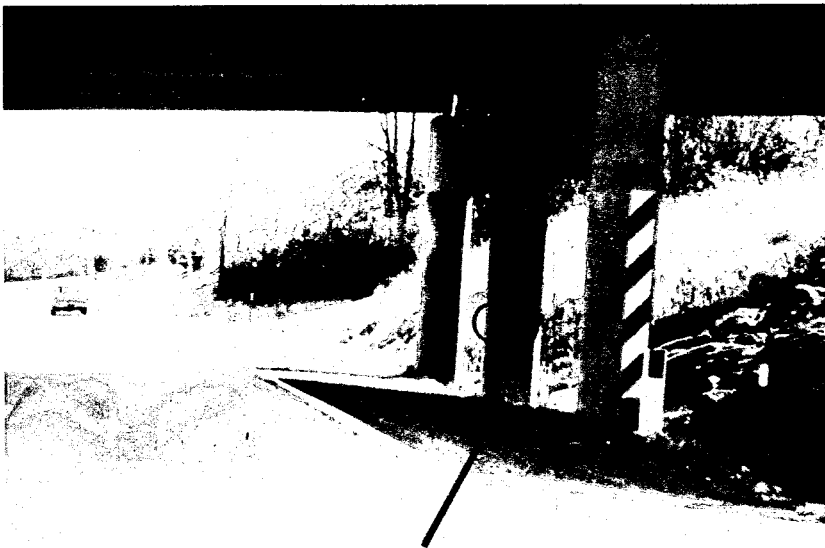
Here you see three posts; the one with the dot, the middle one, has been hit; there is a black spot on it near the bottom. This is Interstate 287; we fail to provide sliding action and protection at these poles.
