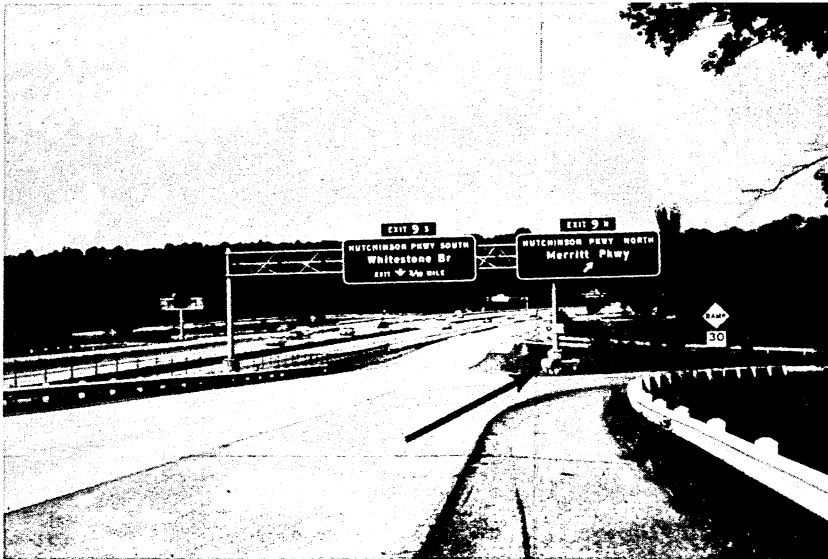
Here is another sign you could have backed up. Give the guy a break. We have neglected this area.

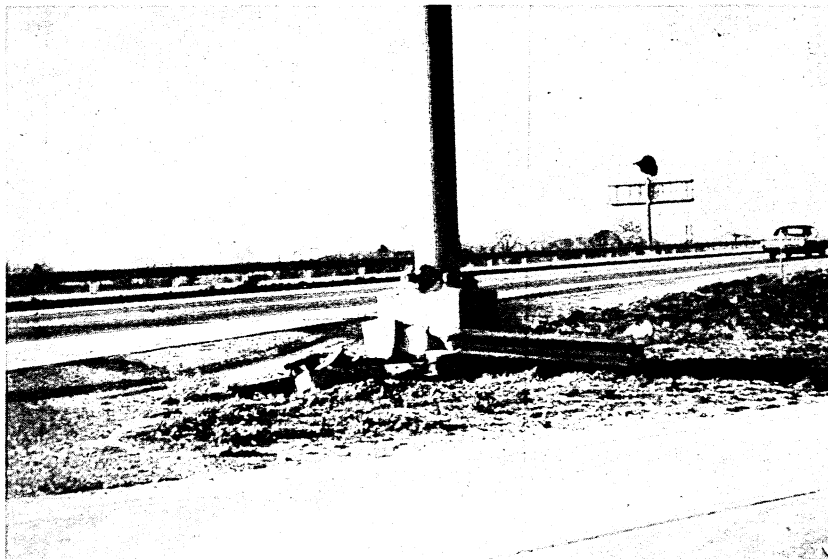
Here you see another one smashed and the book actually recommends that you put these signs there. That gives you a good idea of why some of these are here. In the background you can see the dot showing a similar sign. All of those gore areas are saturated like this. Also, note the improper guardrail; it is supposed to be 40 feet, not 12 feet.
