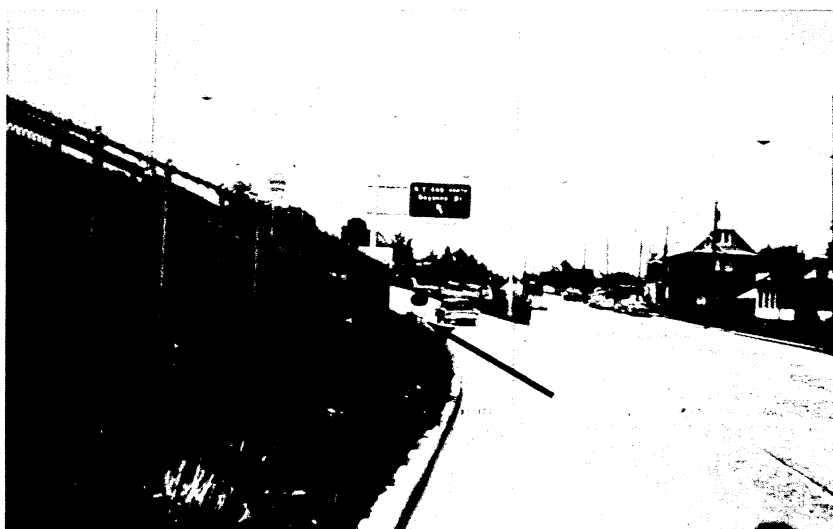
Here you see they did put it here. This is a proper sign installation. But even here they did a half job, because the guardrail protecting this sign that is behind the fence is 2 feet from the curb. It is hard to see. There is a spot there pointing it out. You could run into that thing and wreck your car and it is not even protecting the sign.

Mr. MAY. So we understand, that sign support is behind the fence?

Mr. LINKO. That is right.

Mr. MAY. They have put up that hunk of guardrail to protect—what is the reason?

Mr. LINKO. I do not see any reason. That can smash the car, and it is not protecting anything.

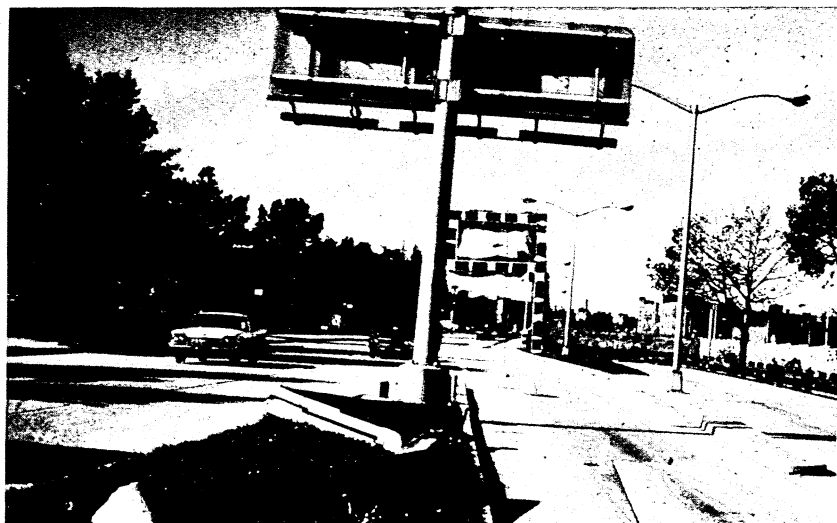
This points out, whether entrance gore areas or exits, they should be off limits to everything. If you could put this sign in advance, up there like I have marked.
