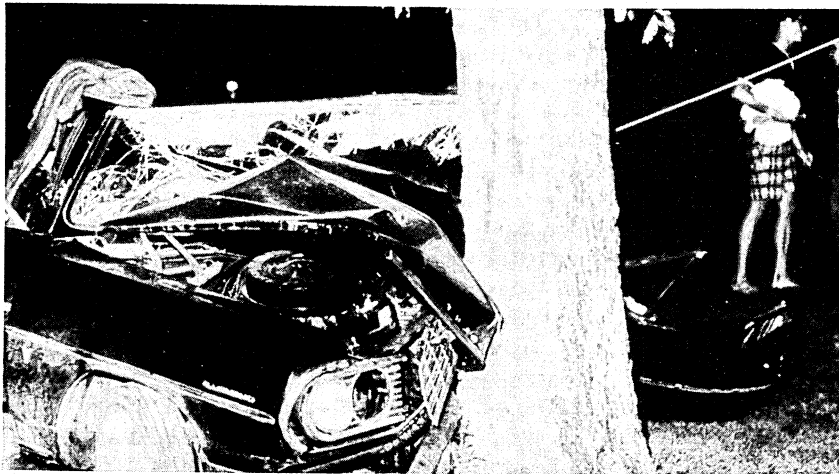
Dr. HUELKE. And this is the on-scene photograph at the time.

Now, this is part of the Michigan highway clearance program. You see that they did remove this tree—but they forgot to remove the tree stump. One night during the deer hunting season, three men were driving in a vehicle, they lost control, went off of the roadway—and this tree stump is 15 feet from the road edge—and the driver was killed. So here is a partial job of tree removal for safety and for other reasons, but they forgot to remove probably the most important part of the tree.
