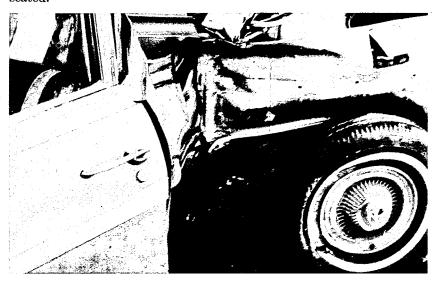
It had snowed during the night. He skidded along the guardrail, which performed like it should; it held, it kept him on track—but the thing is that a few of the legs in here [indicating], near this end, were loose. The car snagged on the guardrail. It then spun around and the left rear door hit the cement monolith, here at the end of the guardrail, crushing the door in, killing the father in the rear seat, and the mother in the rear seat was ejected out the opposite door and down this embankment. She suffered serious injuries.

Had we had these legs implanted more strongly so that it would not rock and snag the car, and possibly the overlap of guardrail over the end here [indicating], this possibly would not have been a fatal acci-

This is the side impact against the door next to which the father was seated

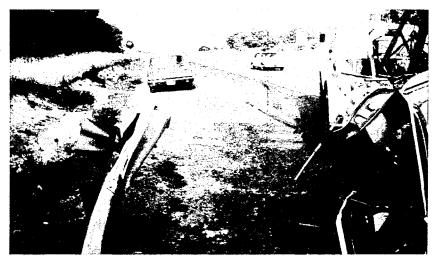
I am standing under an overpass. This is an expressway again. This car (at right in photo) went out of control one early morning. He was
