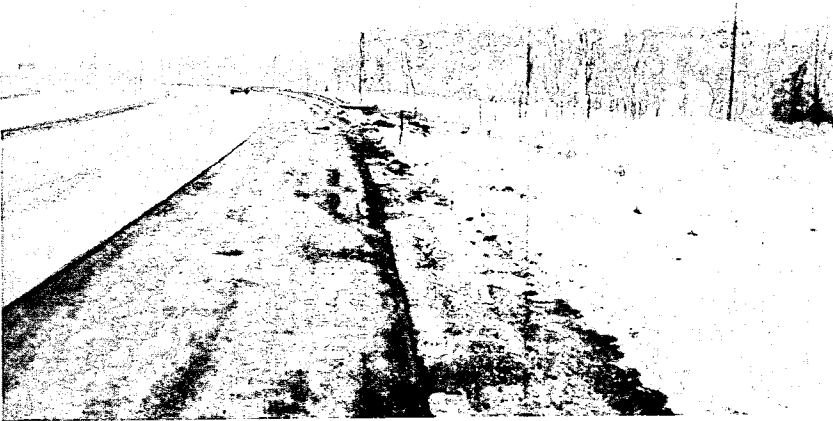
You see, this individual left the roadway, again at a very shallow angle, striking this reflector post. This is the right tire track leading to this guardrail leg.

A long shot shows you how shallow this angle was of his approach to the leg.

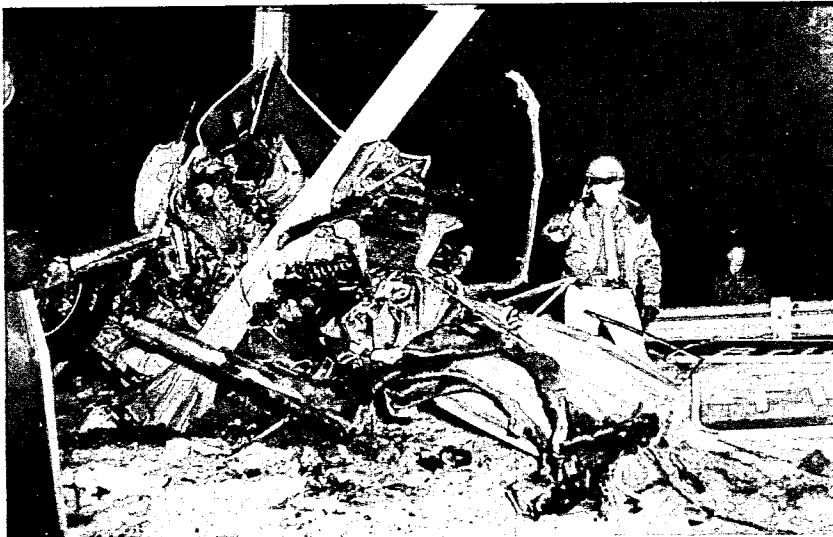
Here is the on-scene photograph. It is very difficult to explain what we have got here, but I will try. Behind the officer is the guardrail and
