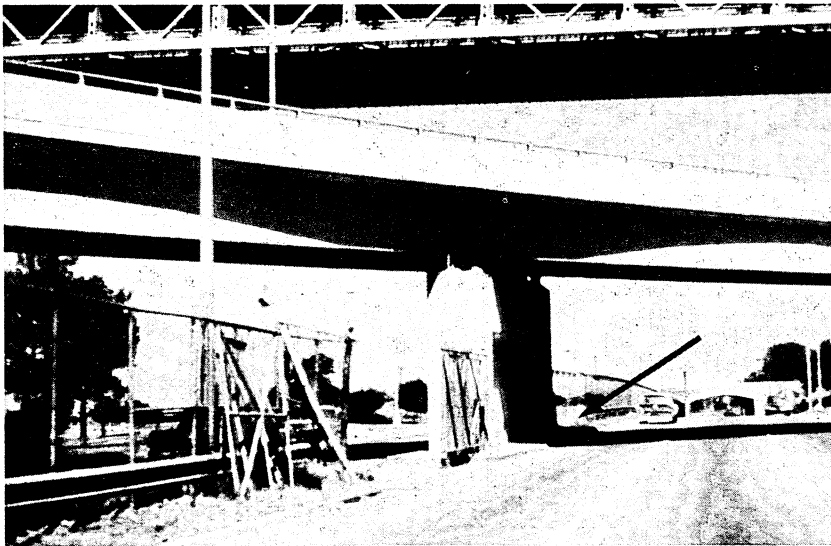
Here you see a line in the fence in the background. This is a new bridge that is being built on top here.

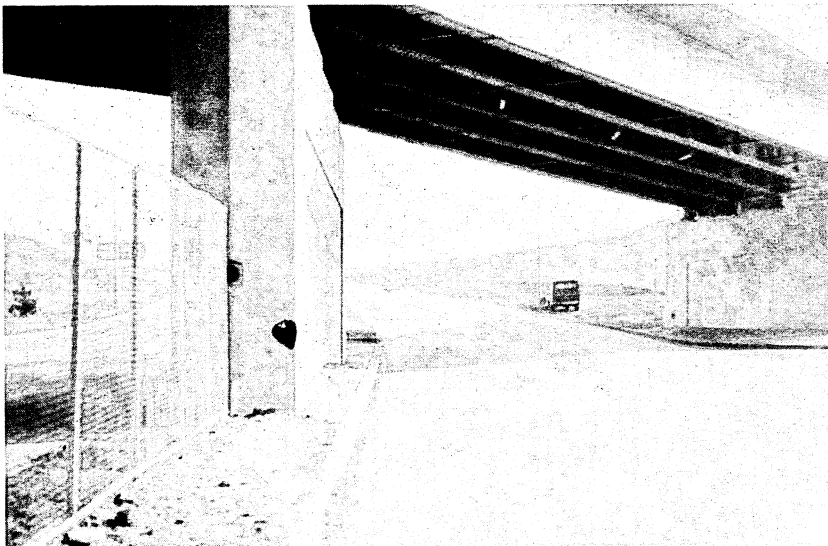
There is the finished job. There used to be a guardrail here, but now that they have finished the job you have an unprotected abutment. This is a serious matter. If we do any new work, we are going to have to protect it.
