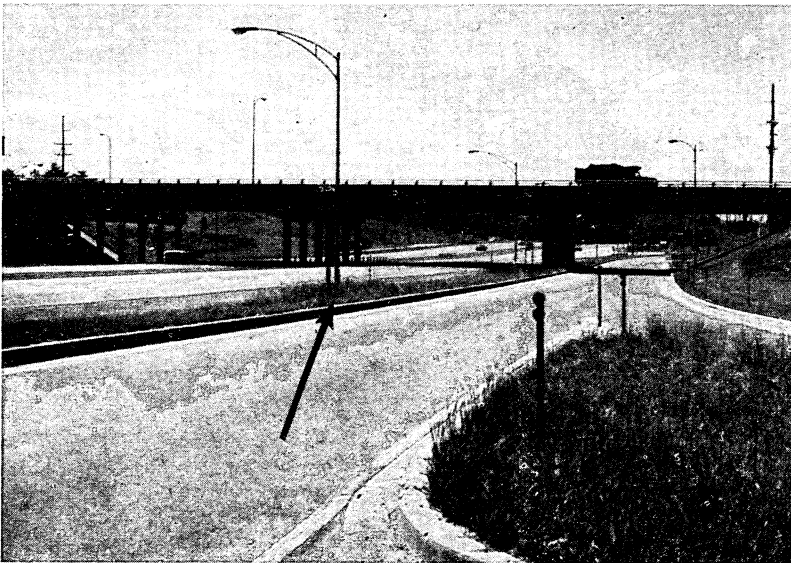
After the accident, the sign was put back up. This is a photograph I took subsequently of the exact location of the accident scene which we just looked at. Now the sign is mounted on one 4-inch I-beam.

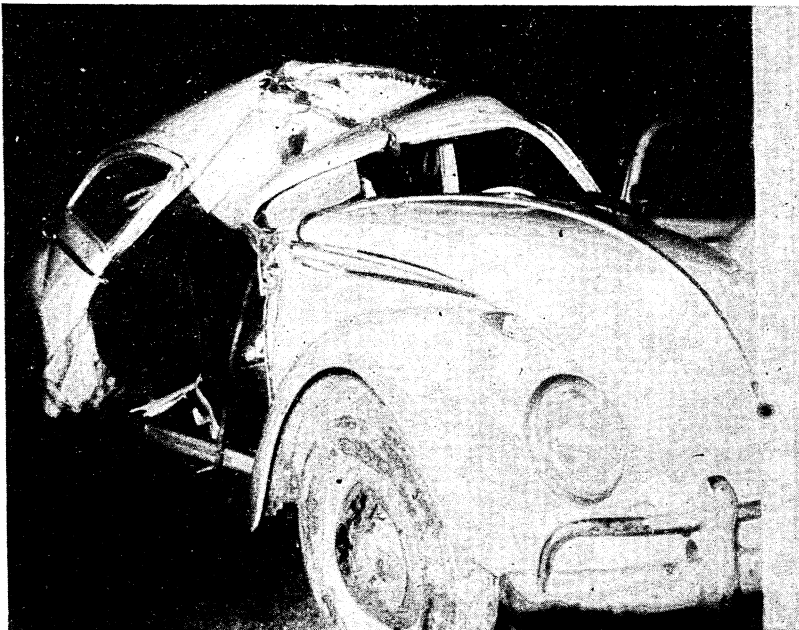
And this is what can happen to a vehicle which hits one 4-inch I-beam. This was a 1966 accident. The driver in this car was severely injured.
