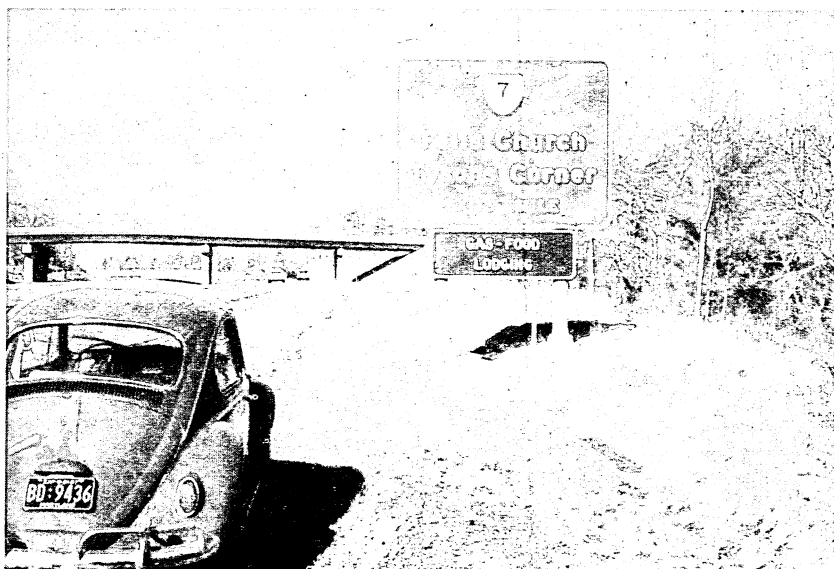
Mr. O'HARA. This is another type sign which you will find on the Virginia section of the beltway. Again you have an extremely large sign. Again, the steel post is mounted in concrete and again a few feet from the shoulder area.

And here we have a concrete drain (indicating). Now the staff has seen photographs and the results of what has happened to a vehicle
