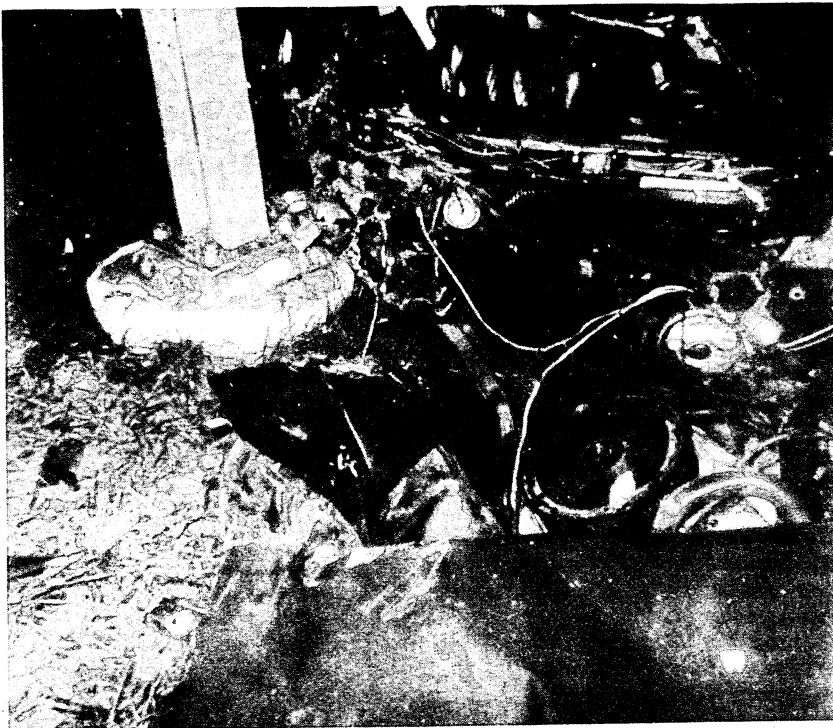
This is the base of that sign support. And you can see that the support has not been damaged.

Mr. BLATNIK. The vehicle is totally demolished and just a few scratch marks on the concrete and on the I-beam, is that right?

Mr. O'HARA. Yes.

Mr. O'HARA. Yes, it did. This accident occurred in October of 1966 and I took this photograph (fig. 3-17) in late December, or early January of 1967.
