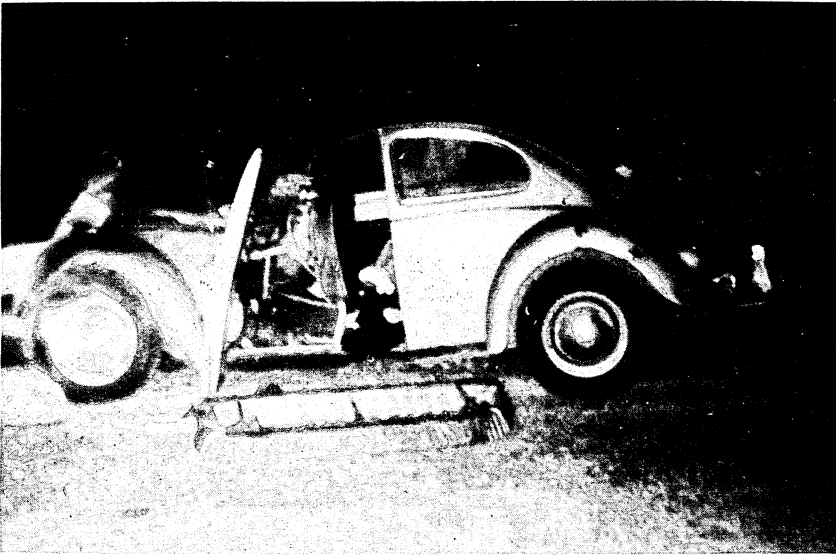
It extended beyond the car. One person was killed and one person severely injured. The same type guardrail installation.

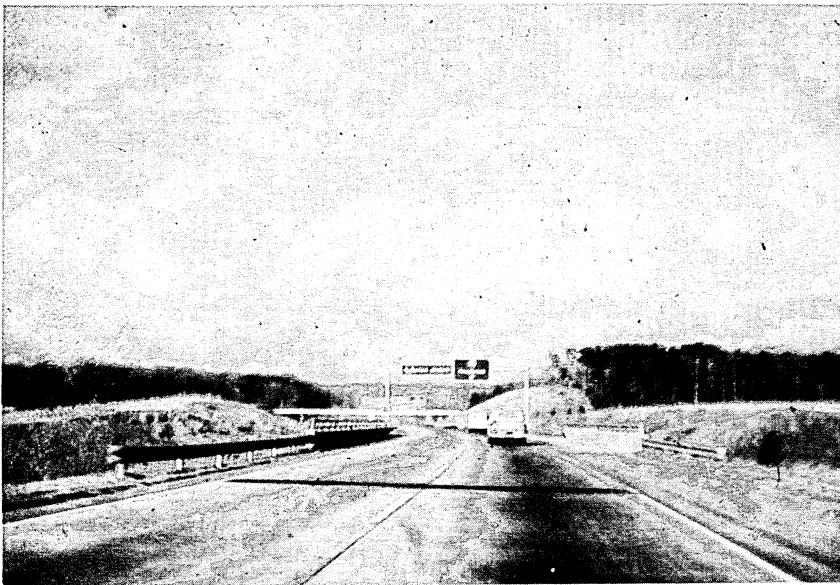
We can go to Virginia and we can find similar situations. Here you have a guardrail approaching a bridge. Here is a guardrail not flared back on the left. The guardrail runs up to the bridge parapet. It is not anchored. On this side the guardrail extends back somewhat like an arrow. It ends at the bridge parapet. In this case they have taken the shoulder through the bridge.
