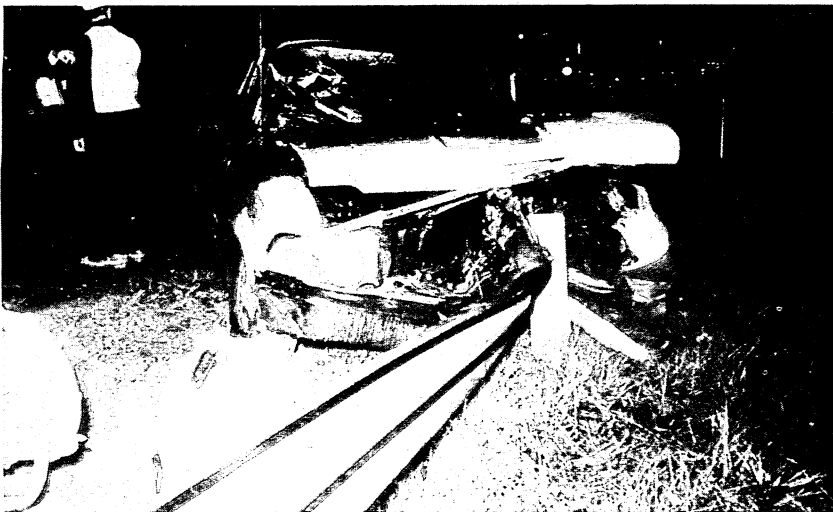
And here again is an accident in Virginia in 1966 where a driver hit the end of a guardrail, and the guardrail end went through the window, through the car, and killed the driver in this case.

Mr. PRISK. I do not think so. The tests that have been made, and certainly the lessons that are displayed all too gruesomely with experience as recorded on these slides, I think teaches that the ends of guardrails need to be taken back away from the road, flared, anchored, otherwise smoothed into the approach alignment so that you have a smooth surface where you have to introduce guardrails.

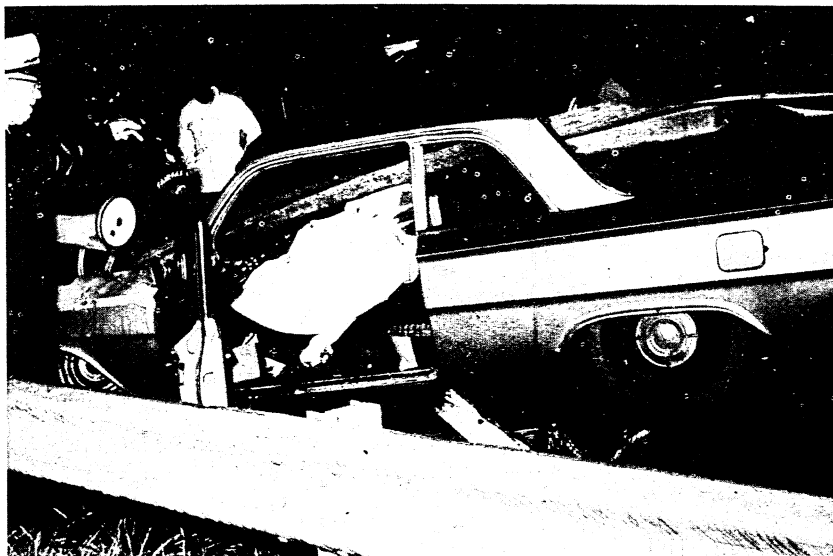
Mr. O'HARA. Mr. Chairman, I would like to say that this photograph was taken on Interstate Route 95 but it is used to illustrate
