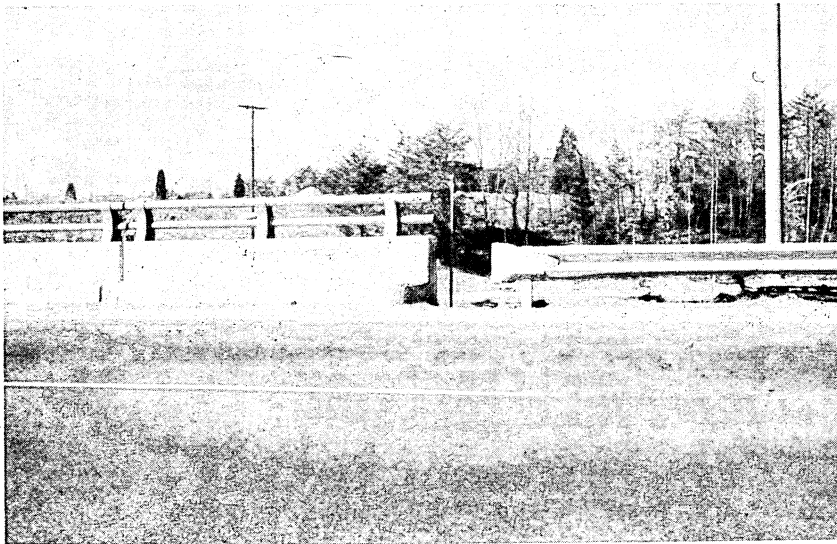
This is a typical installation of a guardrail where it meets a bridge parapet on the Maryland side of the Capital Beltway. This particular photograph was taken in December 1966.

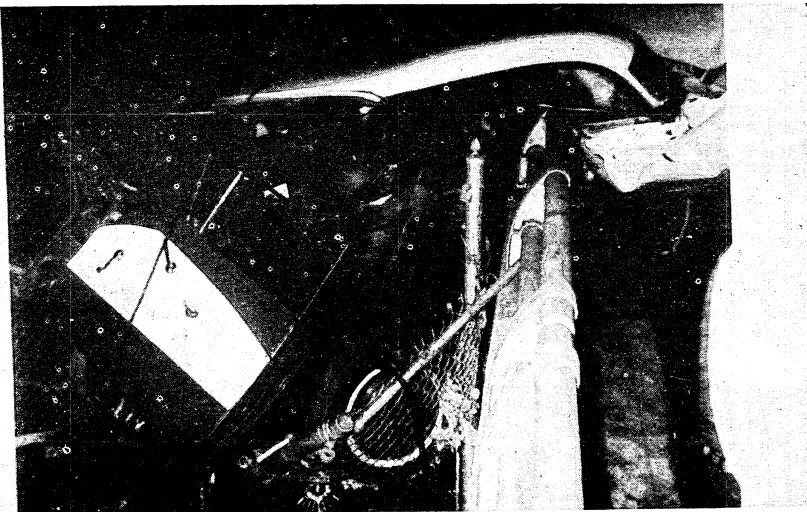
In checking the accident records I found there have been accidents at locations similar to that. This one occurred in December 1965, on the beltway where it crosses University Boulevard. This is in the area just west of the Baltimore-Washington Parkway. This accident resulted in one death and one injury.
