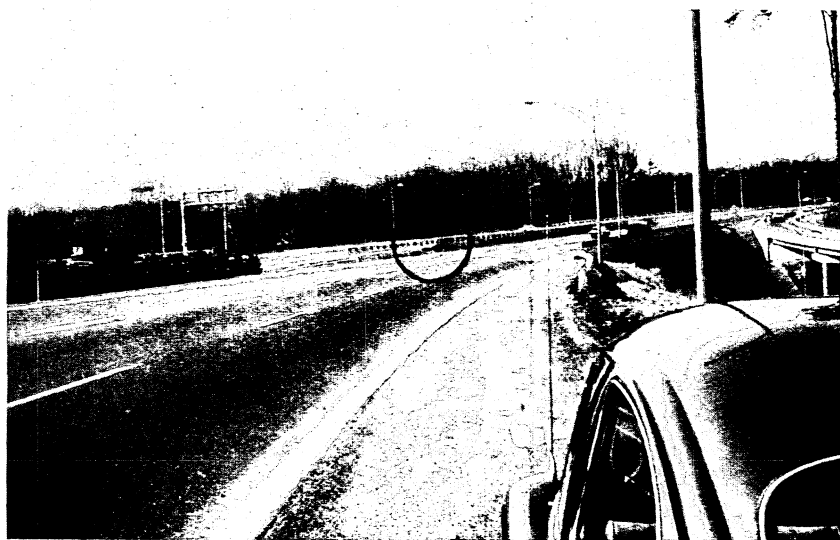
This is a location where I took a photograph in January 1967. The road at this point, which is just south of River Road as you are proceeding toward Virginia on the beltway, crosses over the Cabin John Parkway. The road begins to curve to the right. And on the left your guardrail runs up to the bridge parapet. And on the right the guardrail is again like an arrow, and the shoulder is dropped as you go through the bridge. The guardrail goes up to the bridge parapet and is not anchored.
