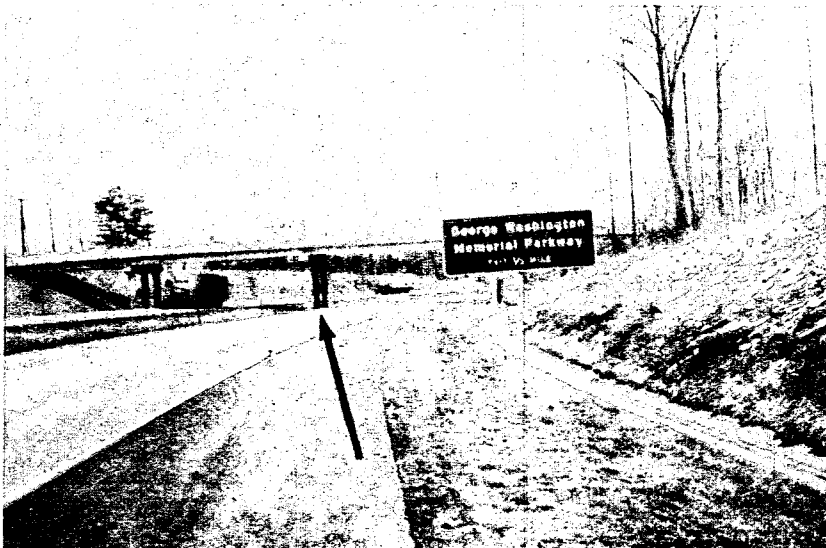
This is a photograph of the approach to the George Washington Parkway on the Virginia side of the beltway. In this area the road is curving slightly to the right and again you will see there is no guardrail to shield a motorist who might happen to wander down in this area [indicating]. Nor is there a guardrail on the southbound
