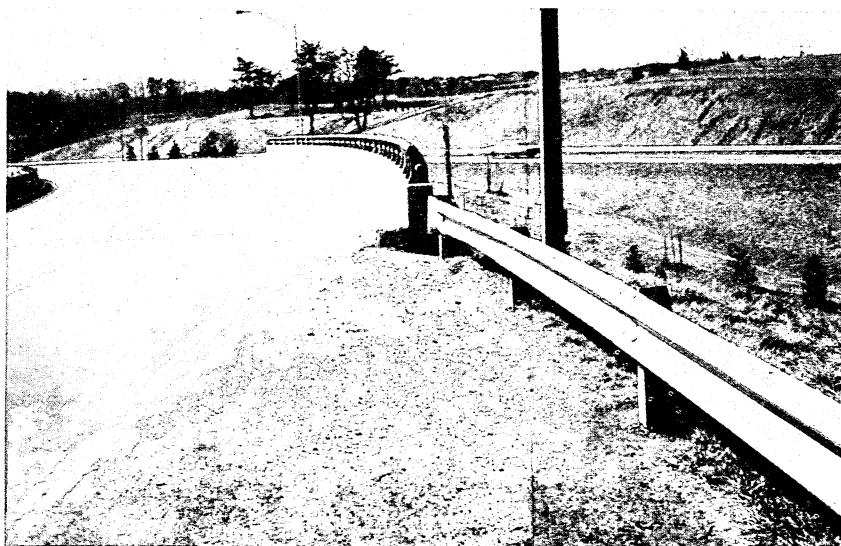
This is the same bridge parapet I was talking about a few seconds ago. There are a number of things to note here. The full shoulder ends before the bridge. The guardrail comes back in toward the bridge parapet. There is a slight shoulder on the bridge. This is a raised curb, and a bridge parapet with guardrail not anchored.

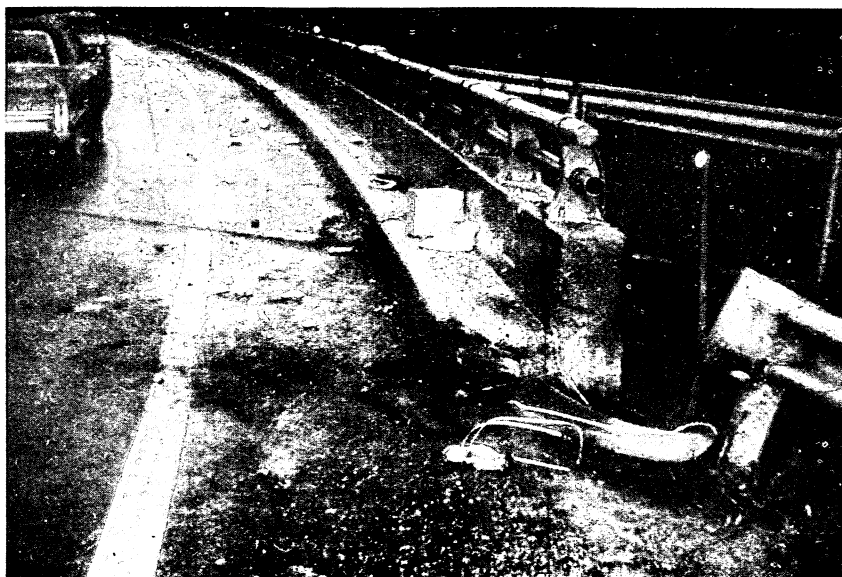
This is that same bridge parapet which in November of 1966 was struck by a vehicle. The vehicle first hit the guardrail, and you can see the guardrail gave way. The vehicle was carried into the bridge parapet. In this particular accident, the vehicle then went across the road—through three lanes of traffic, and slammed into the bridge parapet on the other side, as seen in this picture.
