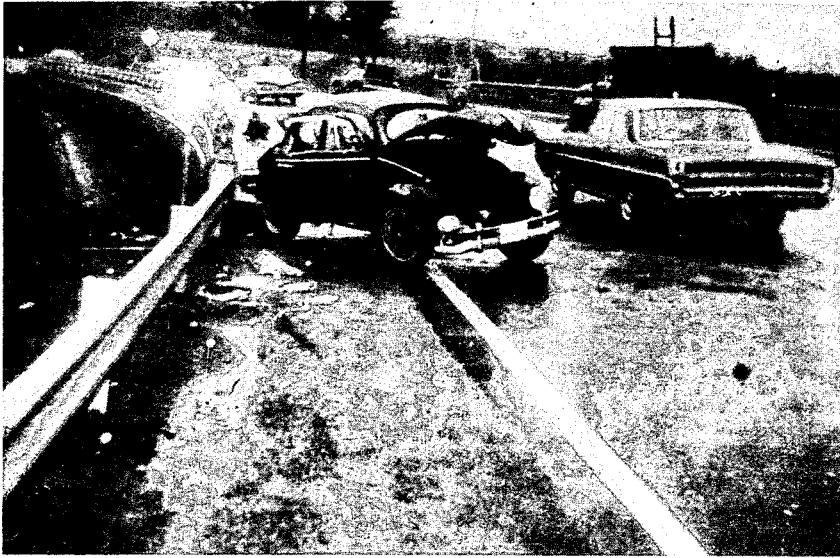
This bridge is skewed somewhat. He was able to hit the parapet end of the other side of the bridge.

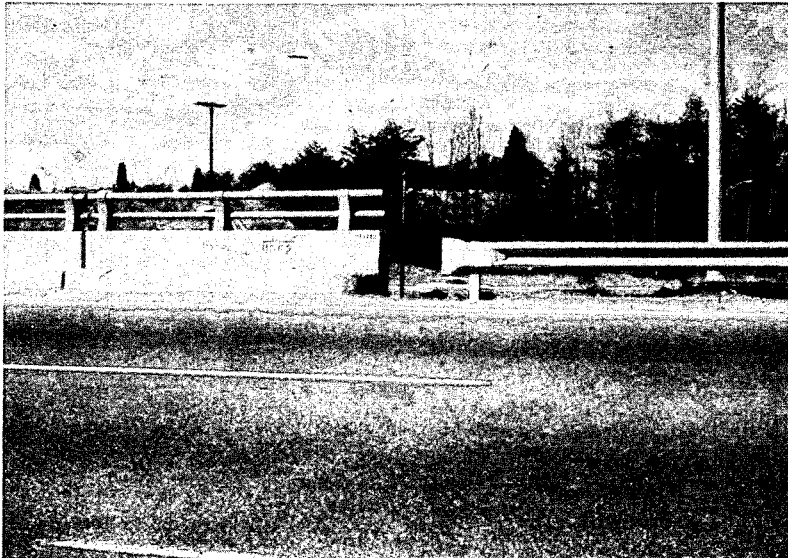
That accident was in November 1966. This photograph was taken in December 1966, 1 month later. This is the way the guardrail was installed after the accident.

In checking the records I found in January, 1 month after I took the last photograph, 2 months after the first accident, a man traveling in the same location went off the road, hit the guardrail which guided him into the parapet and he was killed.
