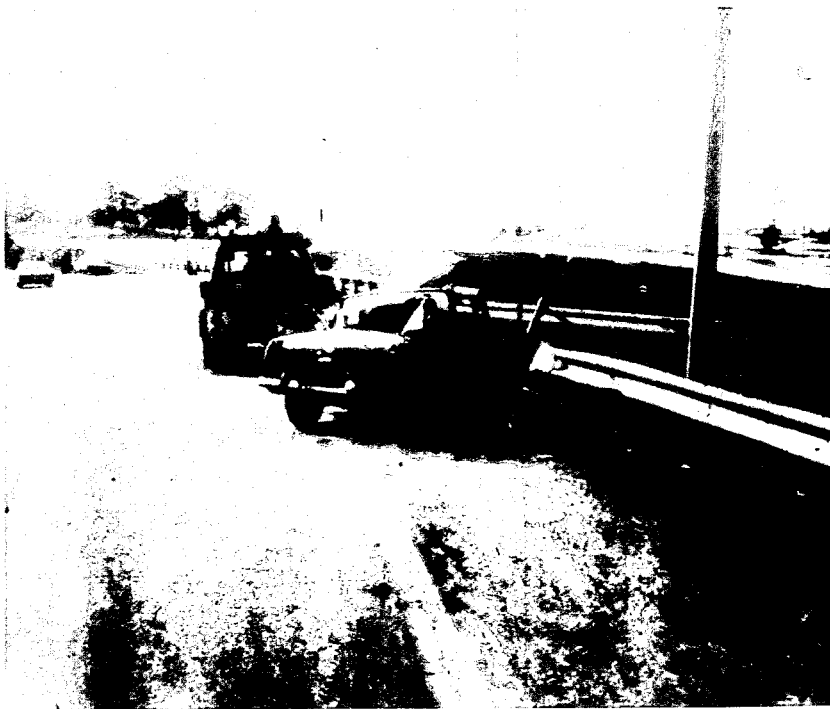
Mr. O'HARA. Yes. One month later we had this accident (figure 3-76) resulting in a fatality.

We saw a few minutes ago the other side of the bridge, where the vehicle hit the guardrail and parapet on the right and then came across and hit this parapet here. This photograph was taken in late December or early January of this year. In checking the accident records, I found that in September of 1966 this vehicle ran into the guardrail and hit that same bridge parapet we are talking about, again resulting in a serious injury.
