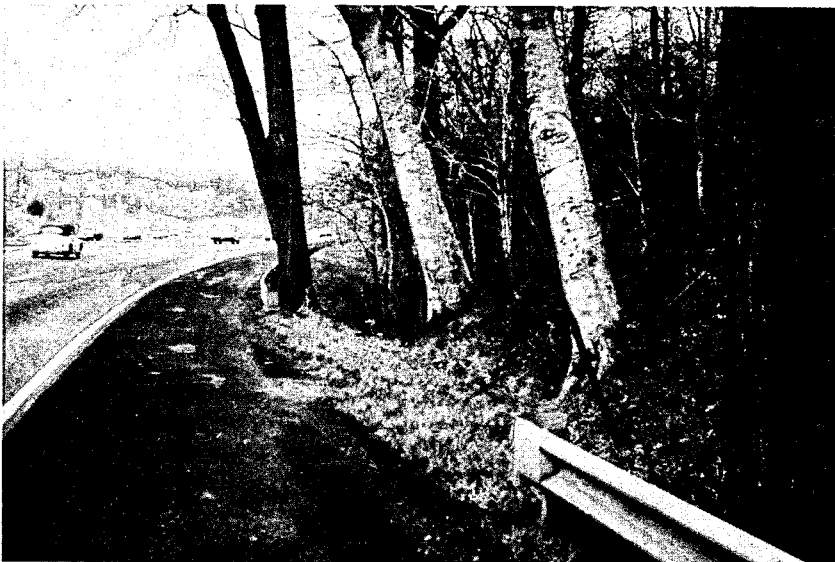
Now the last photograph I took was up in here, looking in this direction [indicating]. We are now heading east again, just east of Connecticut Avenue. Here the road is curving gradually to the left. This is where the road makes a sharp curve. The guardrail ends. A number of trees are back in there, the tree line being somewhat away from the traffic lanes. You can see a heavy front slope, drainage ditch down in there, and a tree line, with the tree line coming back toward the road and the road curving.

Up here is a piece of guardrail and beyond that open space.
