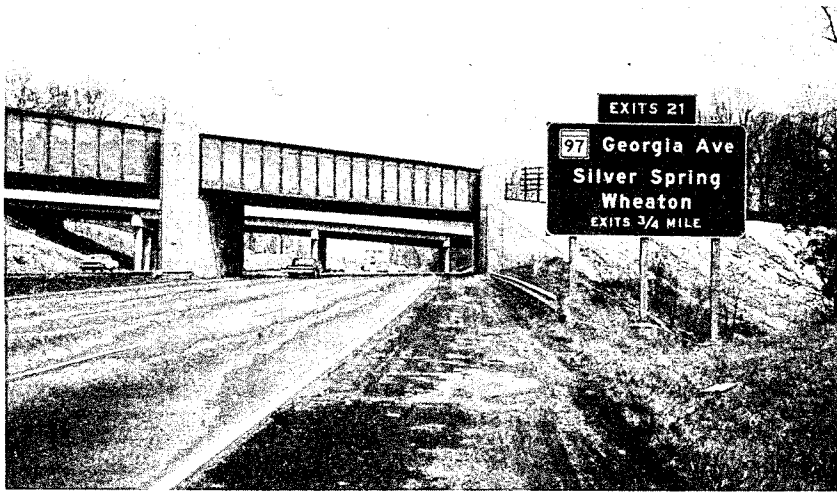
We now are approaching Georgia Avenue. This is Stoneybrook Road on the left. Jones Mill Road is on the right. There are a number of inconsistent things here.

The guardrail extends beyond the bridge here in the median and the guardrail on the right is considerably beyond the bridge. In the westbound lanes, there is no guardrail on the shoulder side and no guardrail on the pier in the median.

The next slide will be taken up in the area of the sign on the right shoulder.

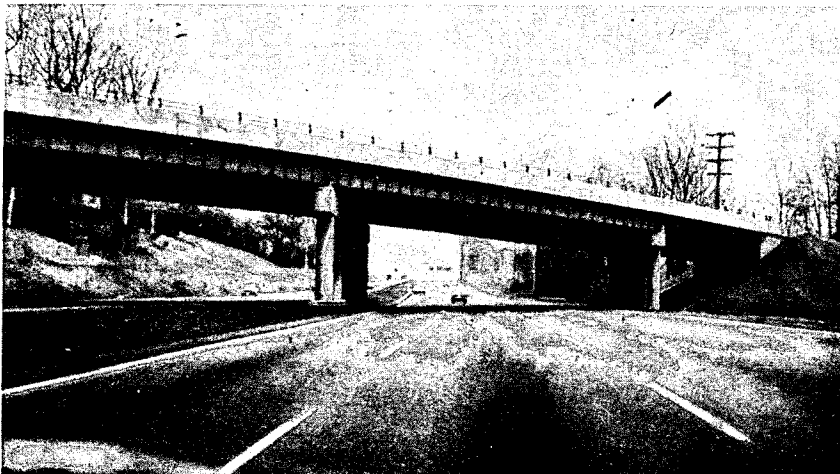
We are now approaching the B. & O. Railroad overpass. Here is the usual guardrail installation with sign supports off the shoulder. There is not too much of a runoff. The guardrail ends before the
